WATERFRONT FACILITY INSPECTION AND ASSESSMENT FUTURE PORTSIDE PIER RESTAURANT

March 18, 2016

Attention: Mr. Greg Mueller, Principal
Subject: Waterfront Facility Inspection and Assessment (WFI)
Future Portside Pier Restaurant San Diego, CA

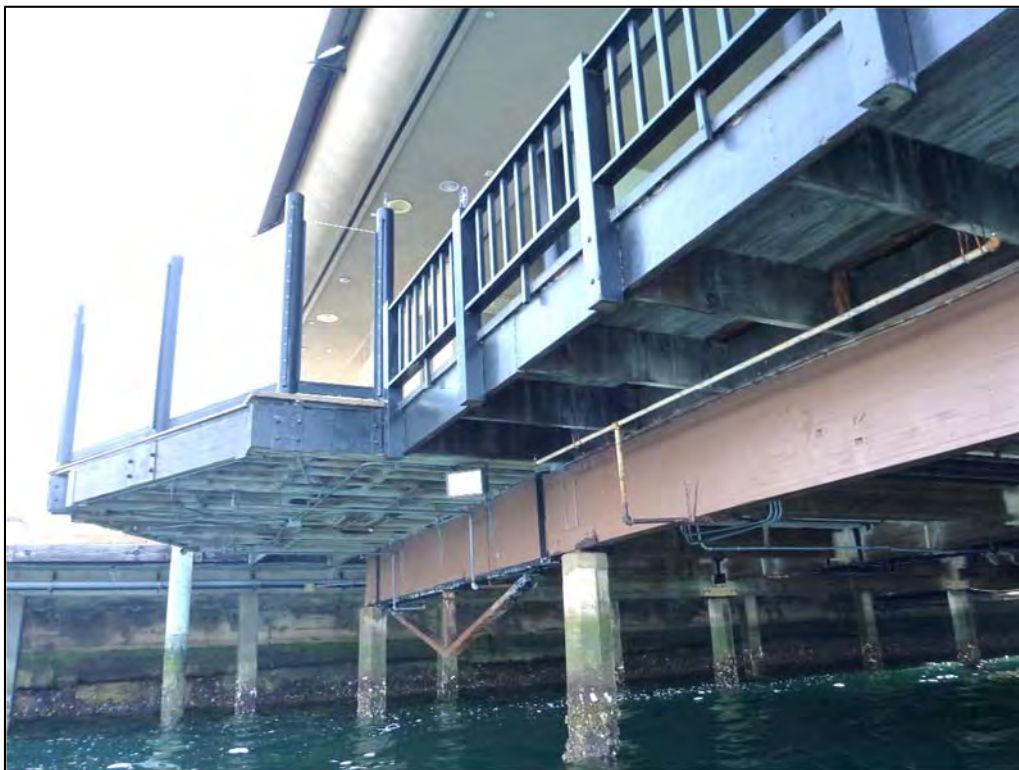
A cantilevered deck addition to the original structure (Photo 3) is located on the north side that was part of the “Star of the Sea” room. Another deck extension is located on the south side for Anthony’s Fishette (patio-style dining). Three prestressed concrete guide piles are located adjacent to the Fishette patio. These piles once supported a floating dock and gangway used for recreational boat access to the restaurant. The floating dock was destroyed during a storm in early 2016. A current view of the south side can be seen in Photo 4.

Photo 3. Cantilevered deck on north side. An inverted steel truss is added to the glue laminated beam supporting the deck framing.

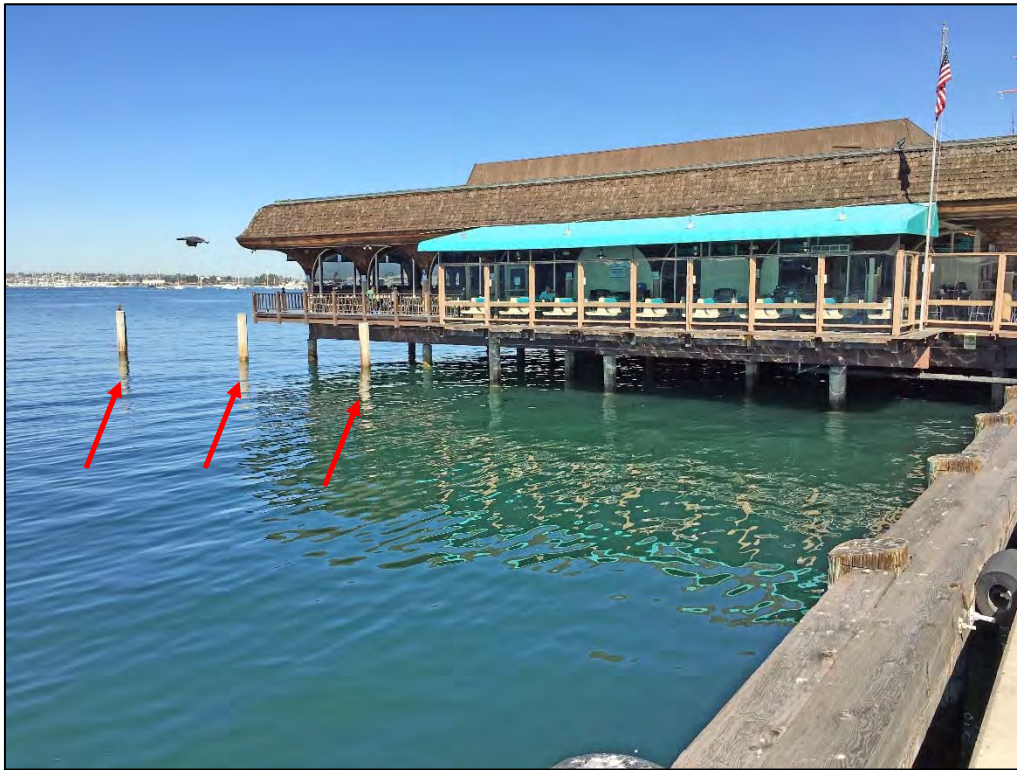
Photo 4. South side of the structure. The arrows point to three guide piles where floating docks were previously attached.

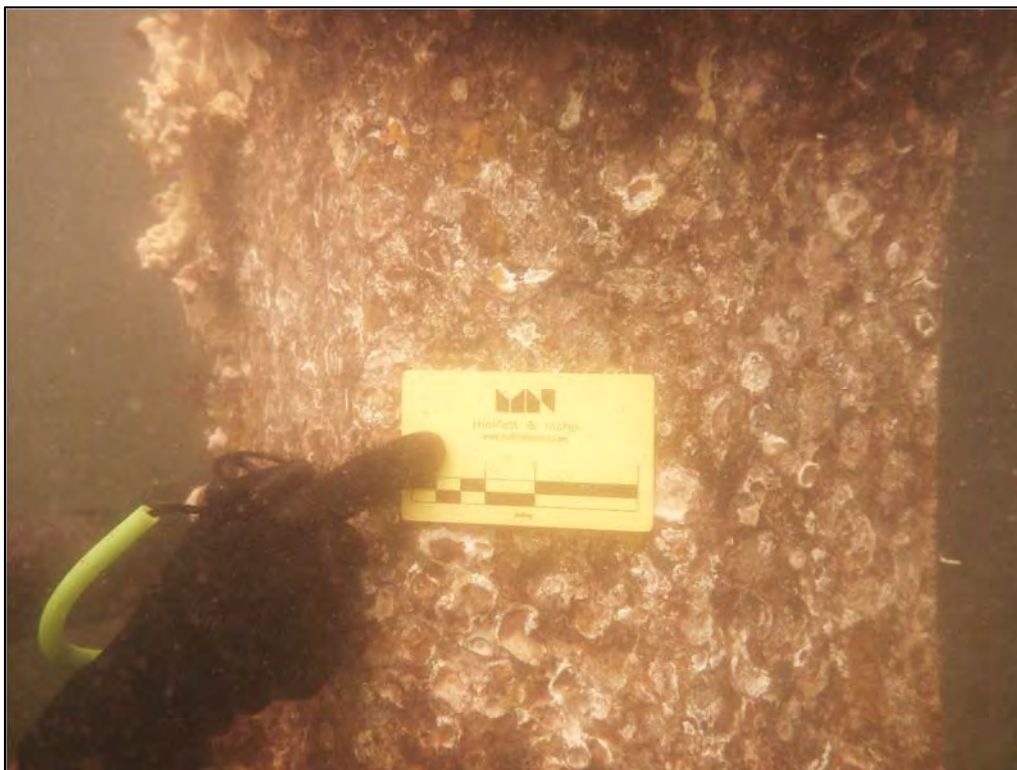
Piles. The structure is supported by 16 in. prestressed concrete octagonal piles. The piles were inspected above and below water. A typical Level II inspection location (removal of marine growth) is seen in Photo 5. Other than the two piles described in “Pile Encasements” below, the piles are in good condition with no defects noted. See Figure 1 in Appendix A: Figures for pile plan layout.

Photo 5. 16-in. octagonal Pile 0:F at a typical Level II cleaning location below water.

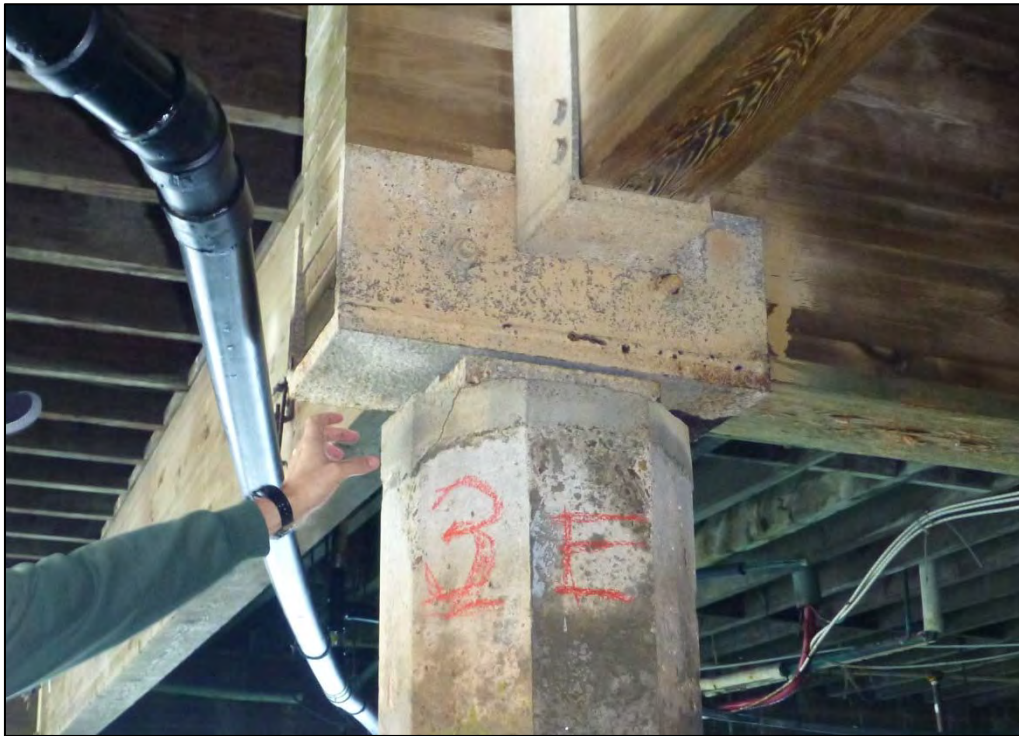
Grout Caps. The piles have a built-up (approximately 2.5-in. high) grout cap which provides consistent elevation for the pile cap connections, see Photo 6. The built-up grout caps are in poor condition with corrosion spalls or cracks noted on approximately 40% of the total. The spalls are a result of steel expanding as a result of corrosion, which tends to delaminate and “pops-off” the concrete. The corroding steel is the result of a combination of chlorides, moisture, and oxygen which serves to create a galvanic cell. This type of degradation is common in a marine environment and is often exacerbated by cracking that originates from impact or pile driving. See Appendix B: Background Information for further discussion of concrete deterioration.

Photo 6. The Engineer points to a diagonal crack in the 2.5-in. grout cap at Pile 3:E.

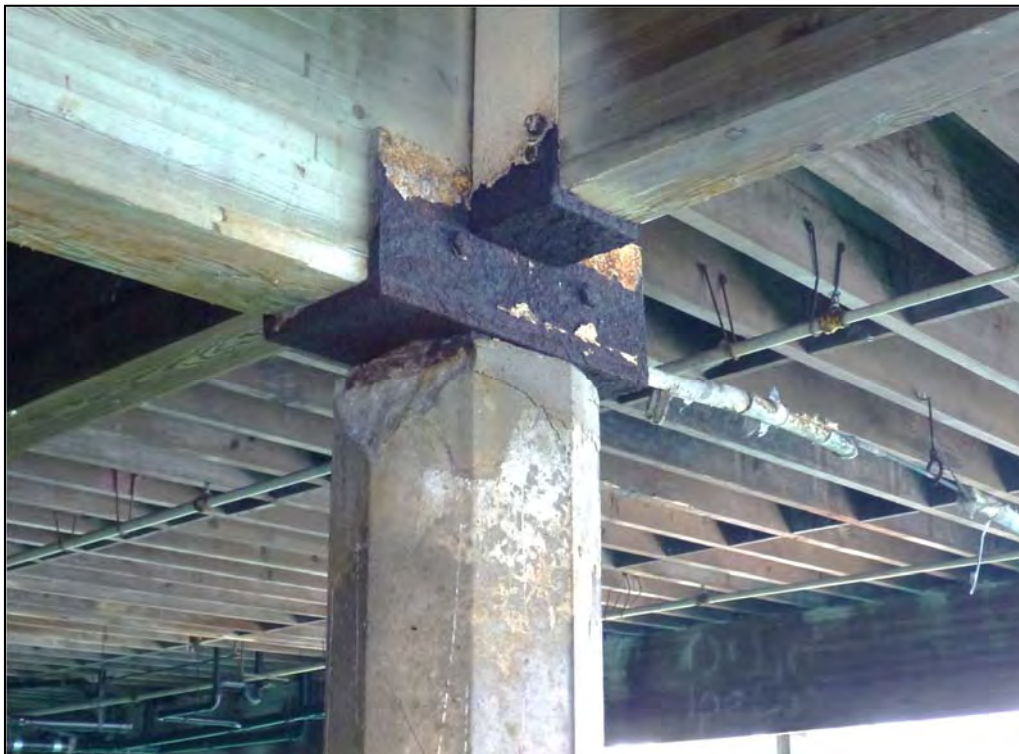
Corrosion of the bearing plate and pin connector is contributing to the spalling and cracking of the grout caps, see Photo 7.

Photo 7. Both the pile cap bracket and the bearing plate are heavily corroded causing spalling of the grout cap at Pile 3:C.

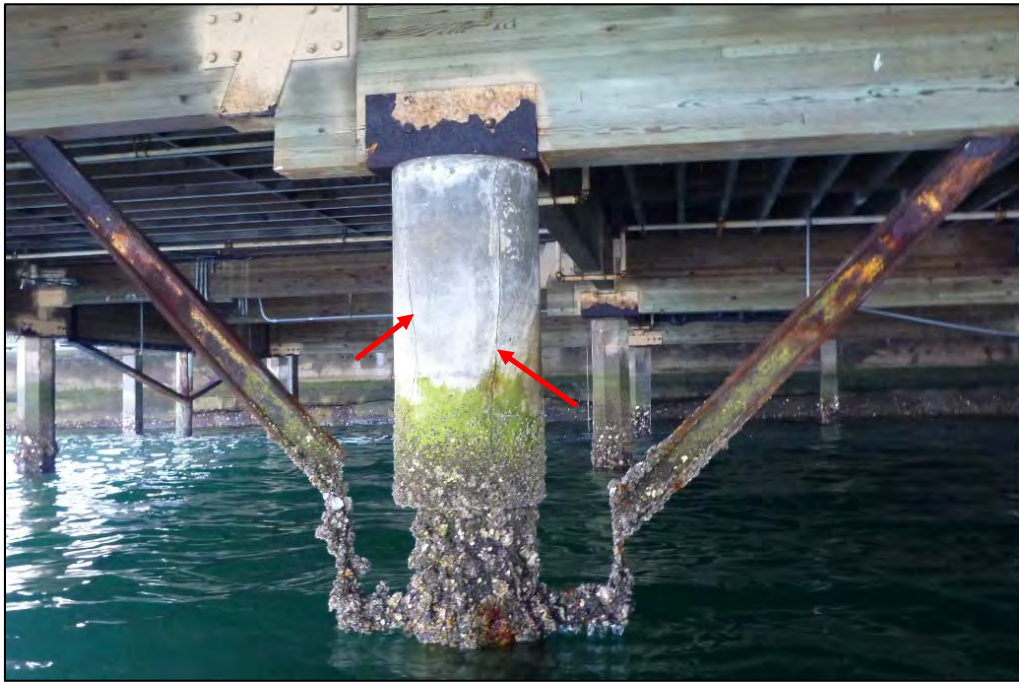
Pile Encasements. There are two concrete pile encasements at Gridlines 14:A and 15:E that extend from the top of the pile down approximately 5 ft. The pile encasements exhibit significant cracking at Pile 15:E (Photo 8) and one has failed (Pile 14:A, Photo 9).

Both piles with encasements have steel bracing that extends from below the encasements up to the pile caps, (seen in Photo 8 and Photo 9). The braces are severely corroded and are in serious condition. The purpose of these braces was to provide additional stability for the pile, while the concrete encasement repair was being performed.

Photo 8. The red arrows point to cracks found in the pile encasement at Pile 15:E.

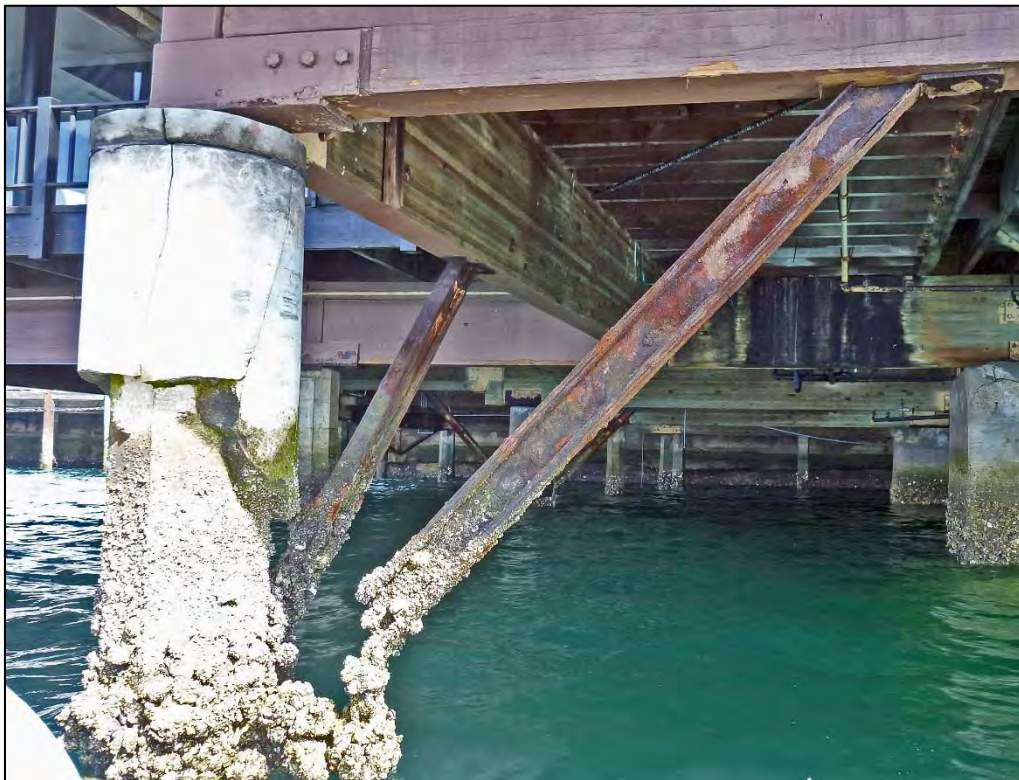
Photo 9. Failed pile encasement at Pile 14:A.

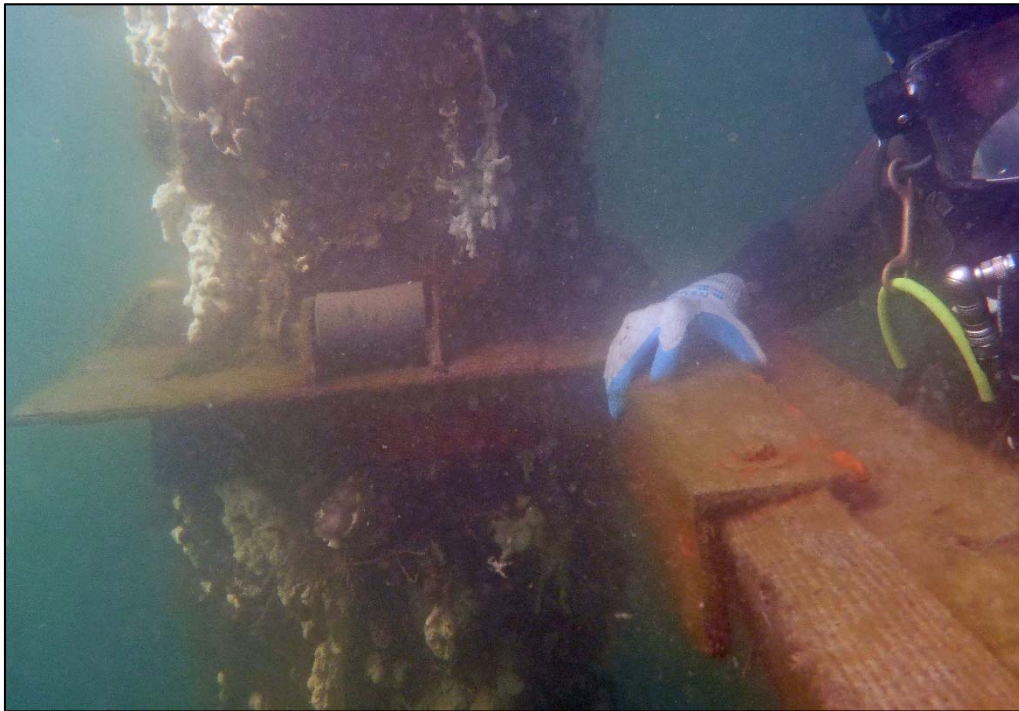
Guide Piles. Three guide piles located on the south side of the restaurant once supported a floating dock to be used by restaurant patrons. The floating dock has since been destroyed earlier this year and remnants of the dock/pile connection were found below water at each guide pile. The guide pile near Grid 0:C had an 8-ft portion of timber stringer attached to the guide pile bracket (Photo 10) as well as additional framing and debris at the bottom.

Photo 10. Guide pile in the vicinity of Grid 0:C. The engineer is holding the guide pile bracket and attached timber stringer.

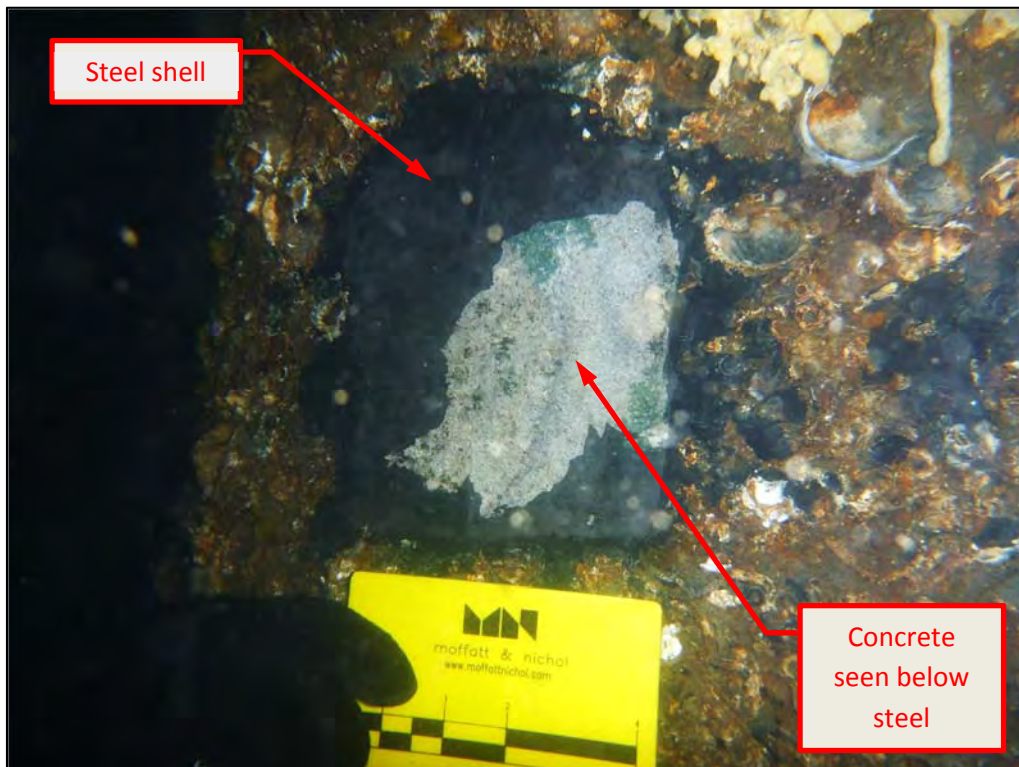
Photo 12. Mid-height Level II at batter Pile 13:G. The partially corroded steel pipe was removed to expose the interior concrete fill.

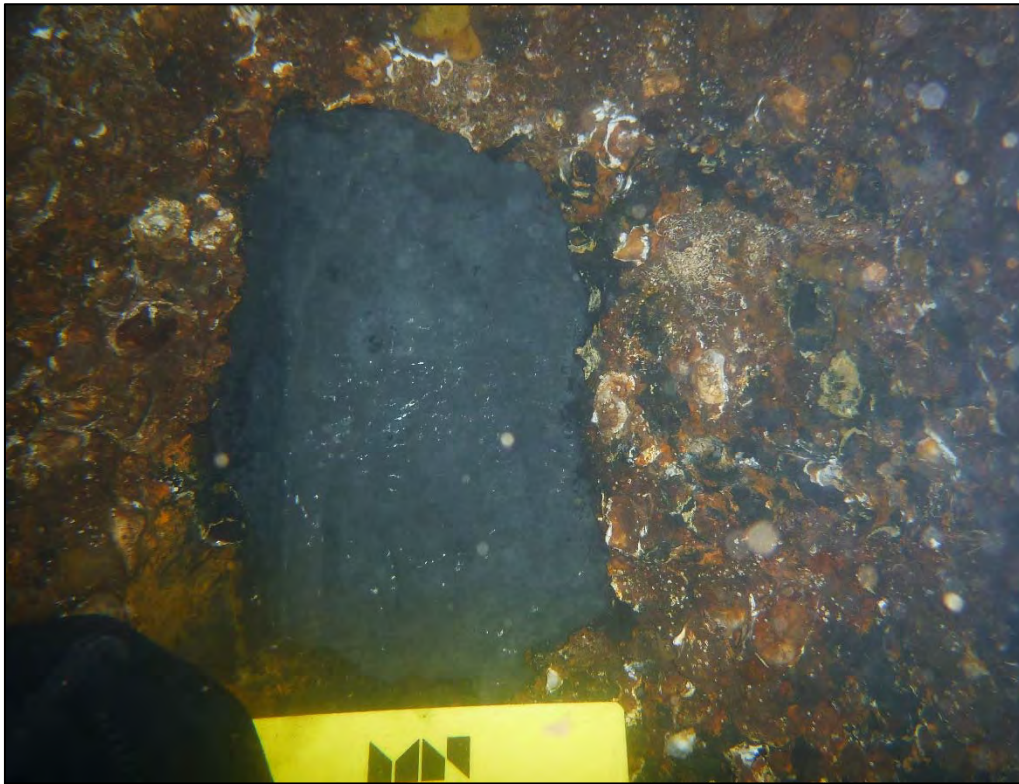
Photo 13. Cleaning band at the top of Pile 13:G where a steel shell was exposed.

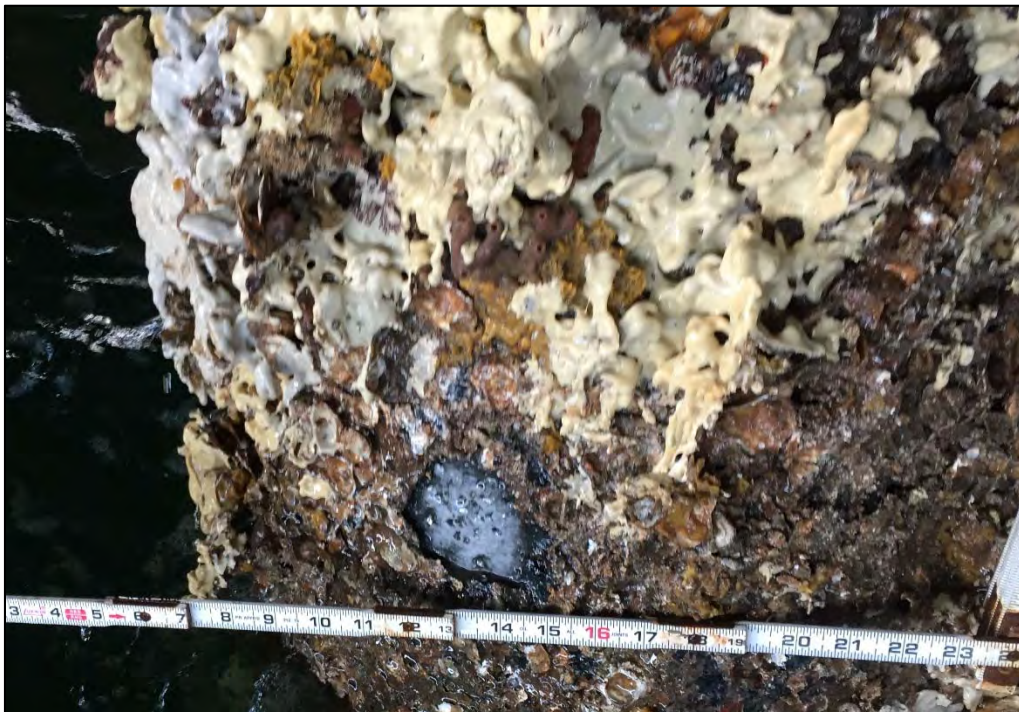
Photo 14. The photo shows the top of the southeast pile of the batter pile group at Grid 5:G exposed at extreme low tide. The steel pipe pile is visible after removal of the marine growth.

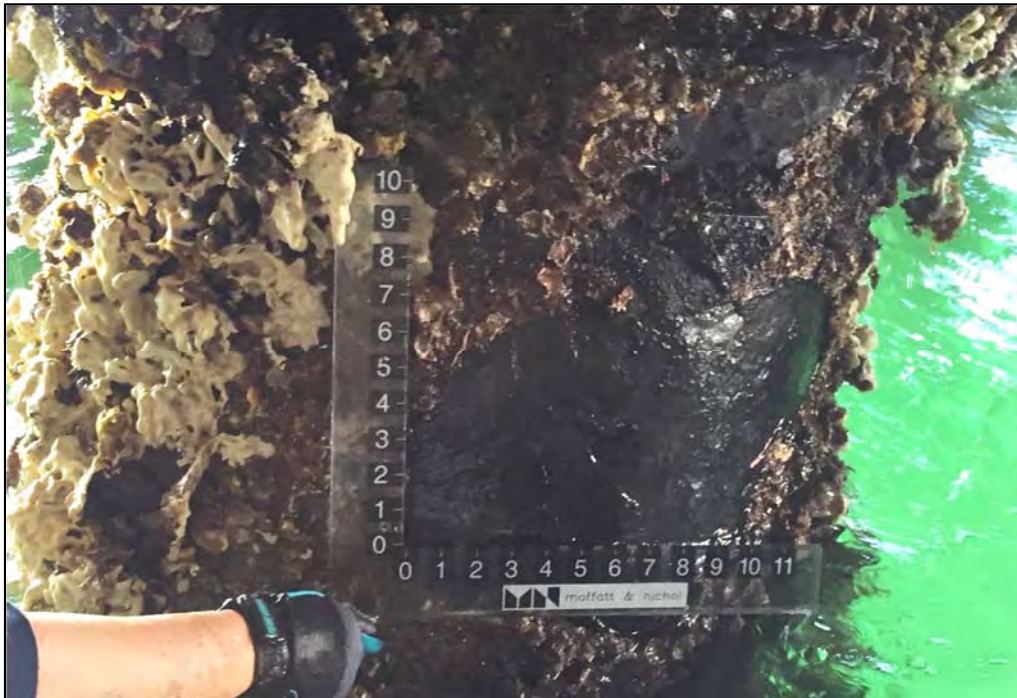
Photo 15. The steel pipe is exposed at the southeast pile of the group at Grid 13:C after removal of marine growth at low tide.

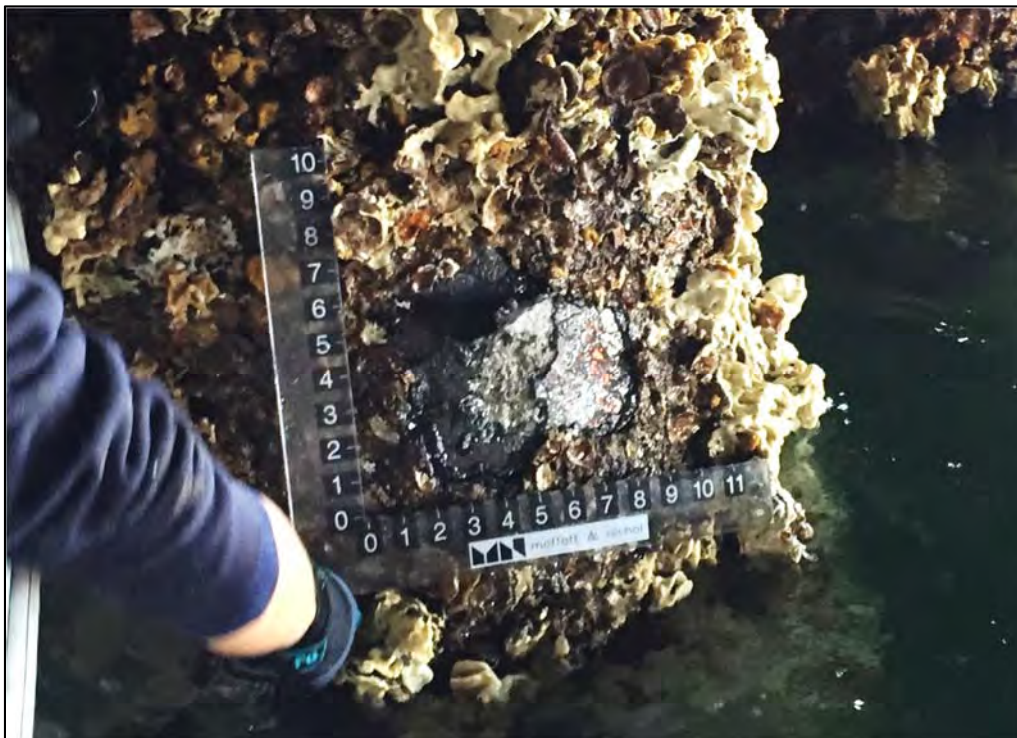
Batter Piles. The Record Drawings (Pertinent Document 2) indicate that the batter piles are 16-in. octagonal prestressed concrete piles, e.g. similar to the vertical piles. Level I and II inspection determined that the piles are actually 24-in. diameter concrete-filled steel pipe. This is a deviation from the Record Drawings. At the mid-height Level II elevation, the engineer-diver hammered through the partially corroded steel pipe to expose the competent concrete fill, see Photo 12. The cleaning band at the top revealed steel pipe as well, see Photo 13. The remaining batter piles were then checked to determine that this pile was not an anomaly. All batter piles were found to be 24-in. diameter steel pipe, see Photo 14 and Photo 15. At the majority of the piles, the engineer was able to expose competent concrete beneath the steel pipe, see Photo 16.

Photo 16. The corroding and delaminating steel pipe is peeled back revealing a concrete substrate (Gridline 13:G, NE Pile).

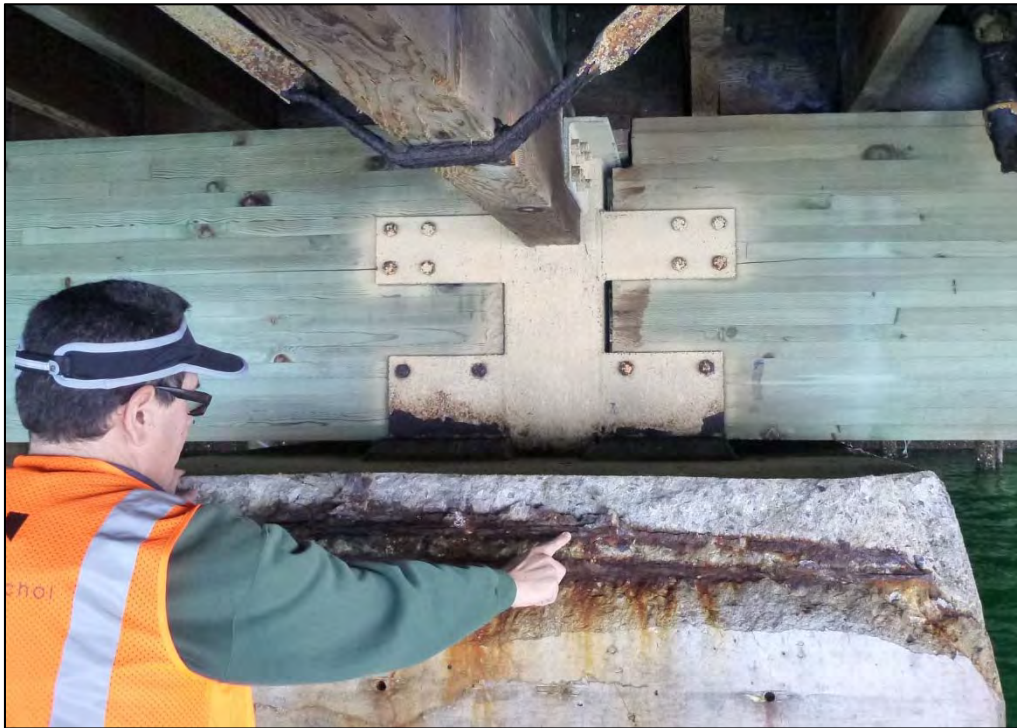
Concrete Pile Cap. The concrete pile caps are 6-ft wide by 7-ft and 3.75-in. tall and are in poor condition. Both outboard (Gridline C) pile caps exhibit significant corrosion spalling on the top corners. The pile cap at Grid 5:C exhibits an open corrosion spall 2-ft high and 10-in. deep along the entire west face, see Photo 17. At Grid 13:C, the pile cap has a similar defect and has been previously repaired. The repair is also failing, see Photo 18.

Photo 17. Open corrosion spall at Pile Cap at 5:C.

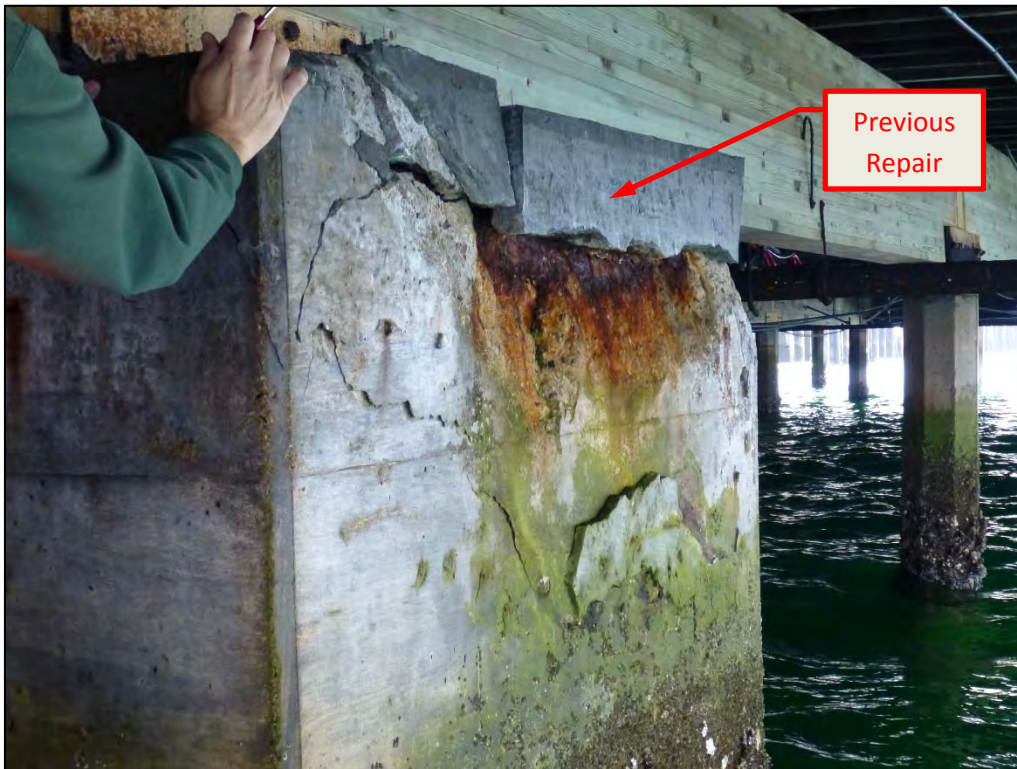
Photo 18. Failed repair and open corrosion spalling at Pile Cap at 13:C.

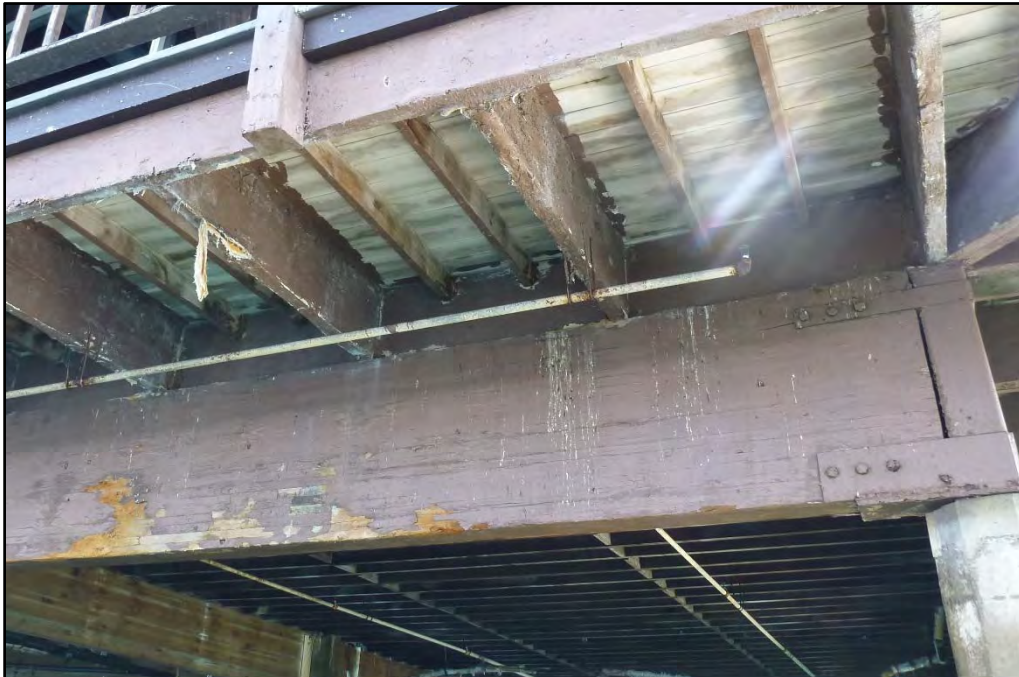
Soft Rot. The paint on the perimeter pile caps is failing in several areas with soft rot noted beneath (Photo 19). Soft Rot is caused by fungi related to molds. Soft rot typically is relatively shallow; the affected wood is greatly degraded and often soft when wet, but immediately beneath the zone of rot, the wood is typically firm. Because soft rot usually is rather shallow, it is most likely to damage relatively thin pieces of wood such as stringers. It is favored by wet situations but is also prevalent on surfaces that have been alternately wet and dry over a substantial period.

The pile caps that are affected by soft rot typically exhibit less than 10% of section loss on the bottom face. The rot is seen on the perimeter glulam pile caps or underneath areas that have been exposed to prolonged moisture (leaks or drains).

Photo 19. Pile Cap at Bent A spanning from Gridline 1 to 3 with failing paint and soft rot noted at the areas of exposed wood.

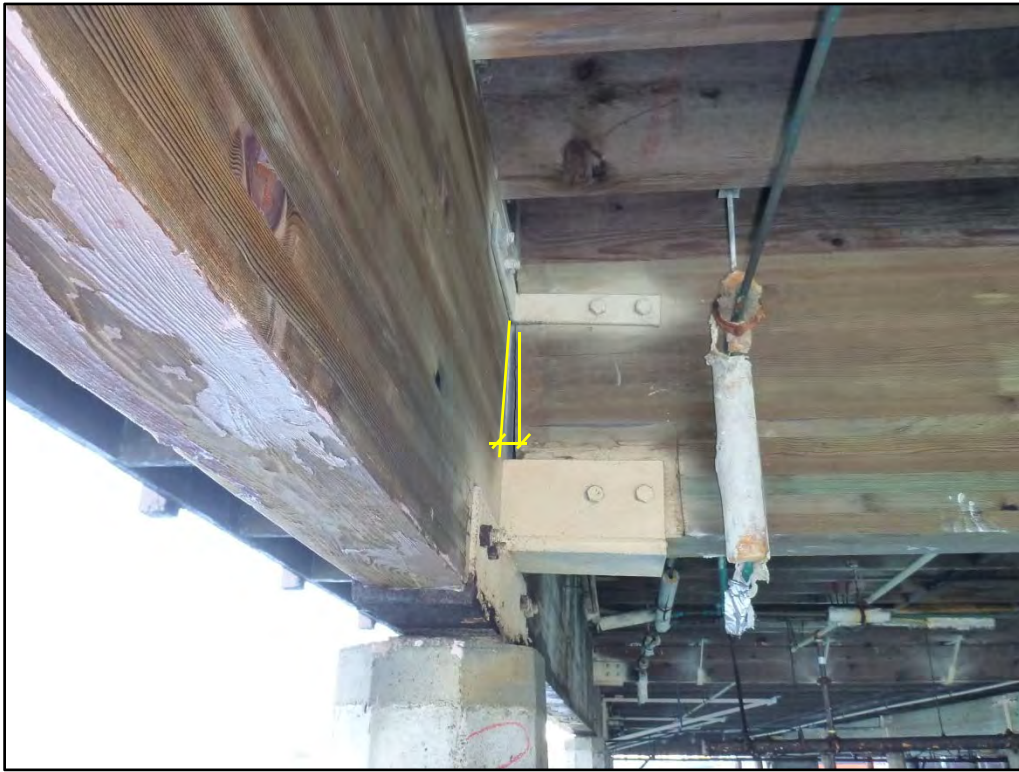
Rotation. The pile cap at Bent A spanning from Gridline 1 to 5 is rotated inward, see Photo 20.

Photo 20. The lines highlight rotation of the pile cap (left-hand side) at the connection above Pile 3:A.

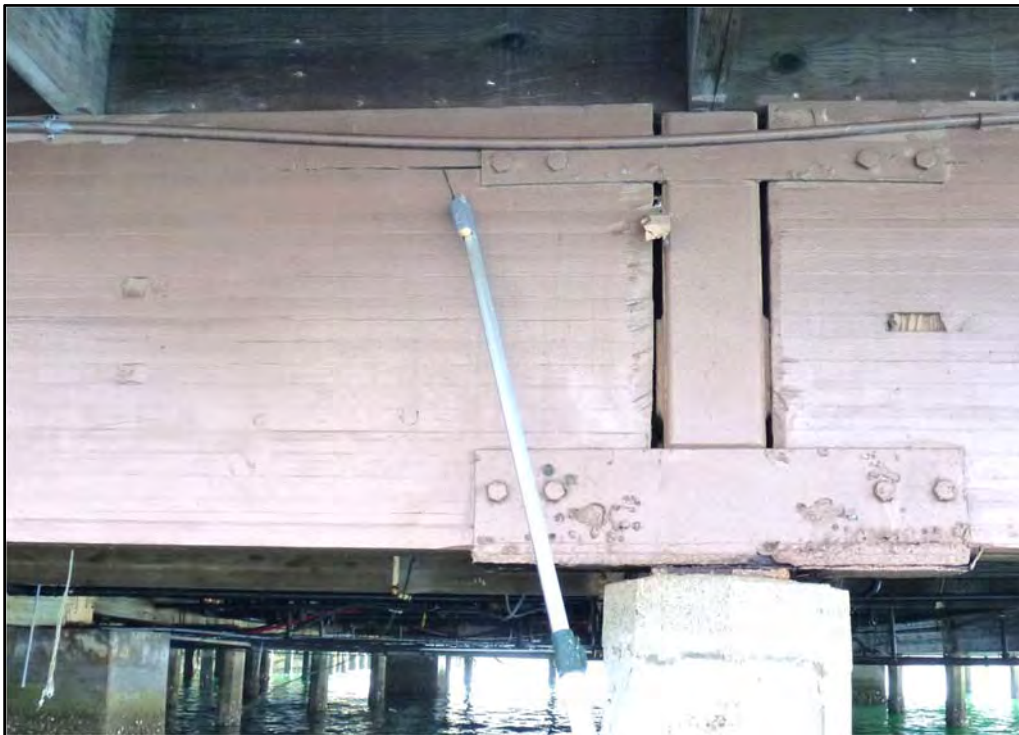
Splits. In several places, splits were noted in the pile cap at the top bolts of the pile cap brackets, see Photo 21.

Photo 21. Split noted in the pile cap just to the right of Pile 17:E.

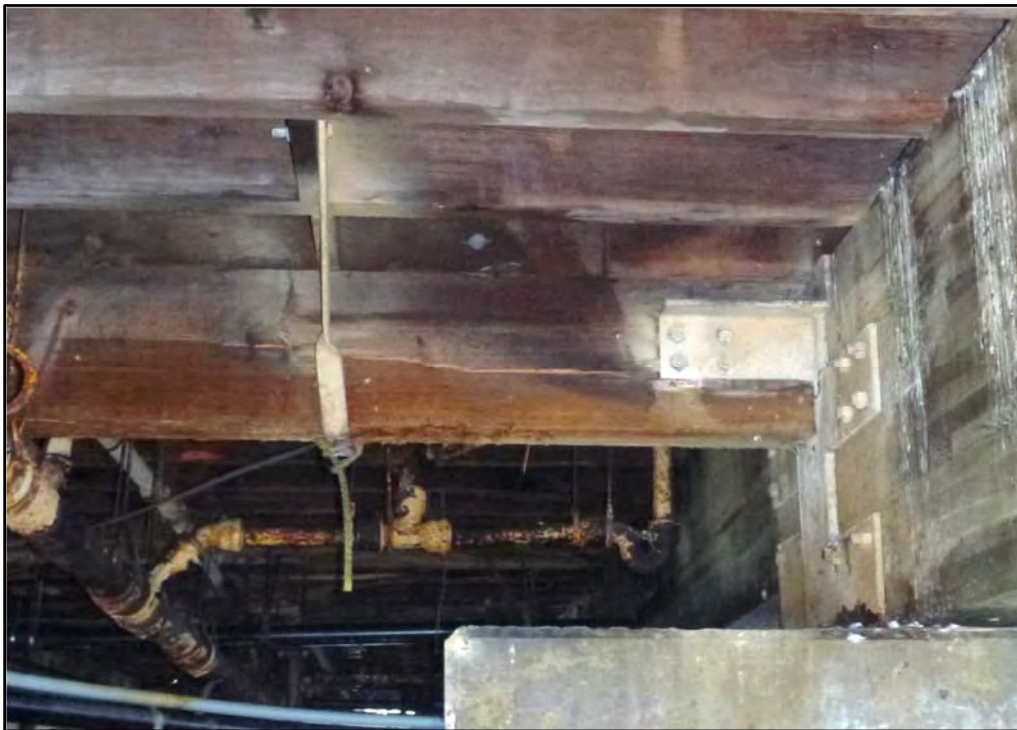
Photo 22. Split in the 6x14 girder above the batter pile group at Grid 13:G.

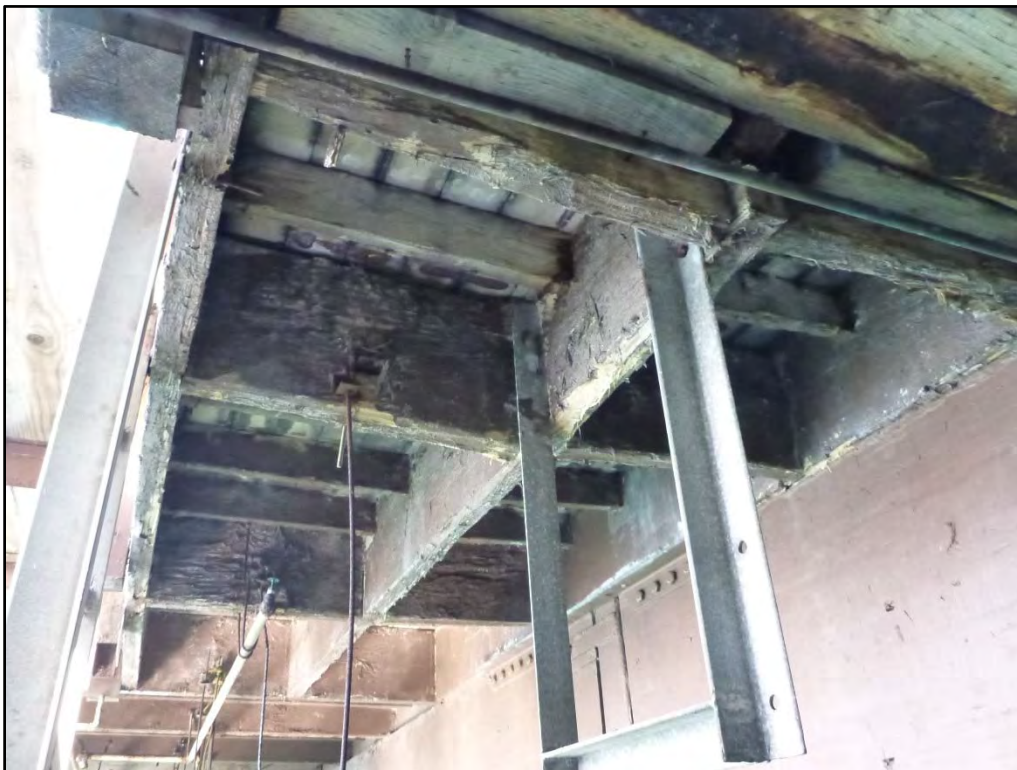
Photo 24. Soft rot noted on stringers supporting the exterior back in the vicinity of Grid 1:J.

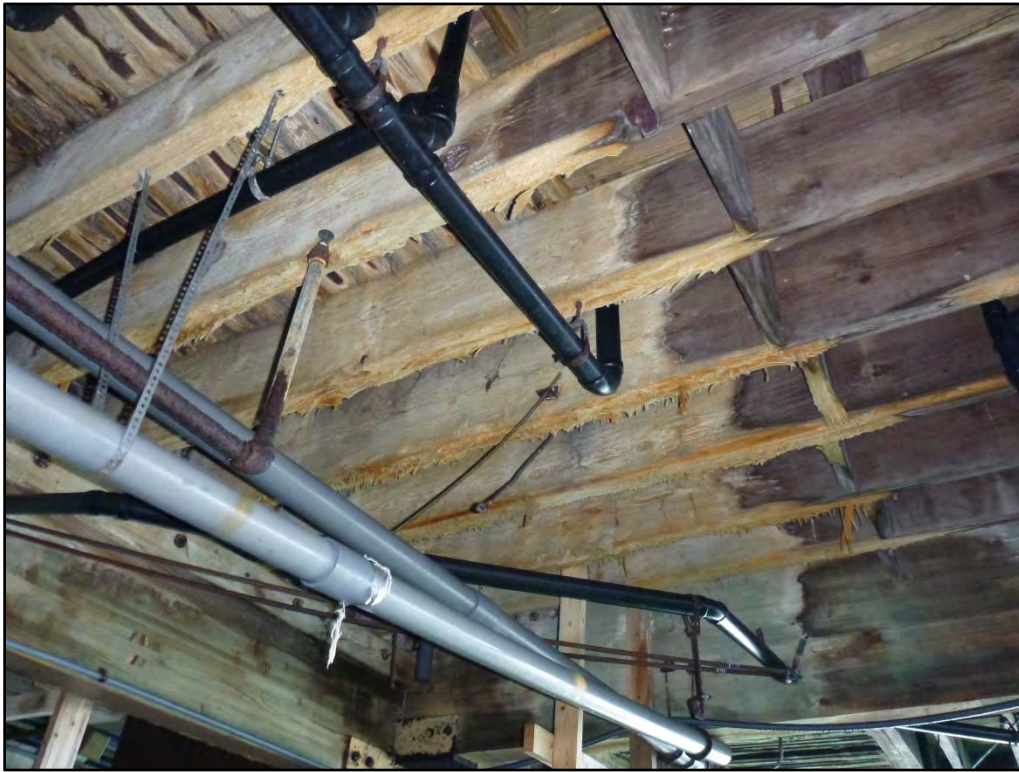
Photo 25. Soft rot on stringers noted in the vicinity of Grid 3:J.

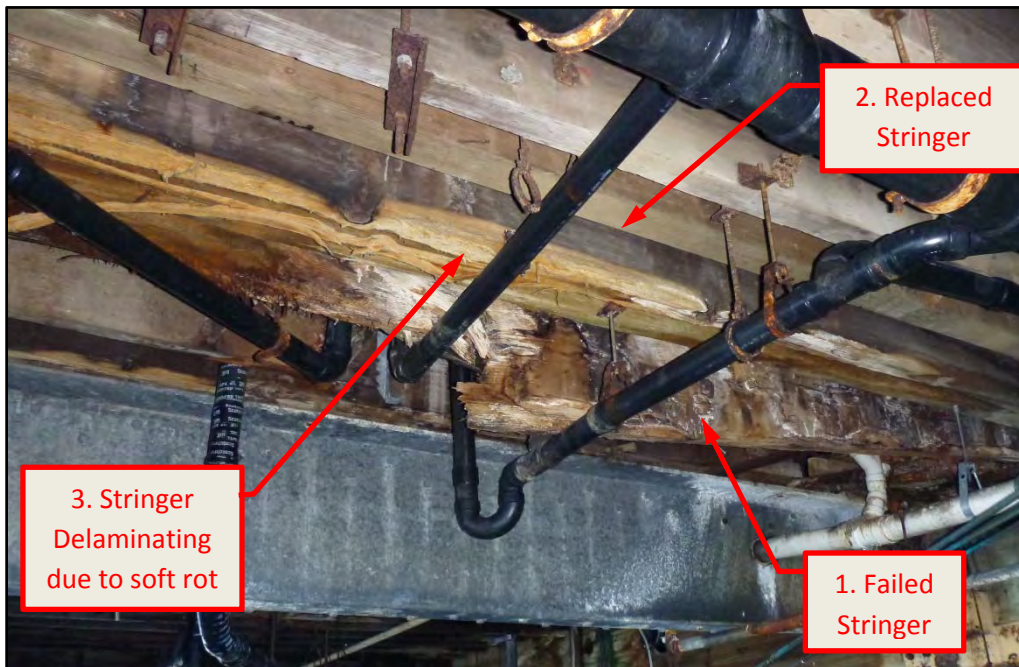
Photo 26. A failed stringer (1) has been replaced with a newer stringer (2). Damage due to soft rot is seen on an adjacent stringer (3).

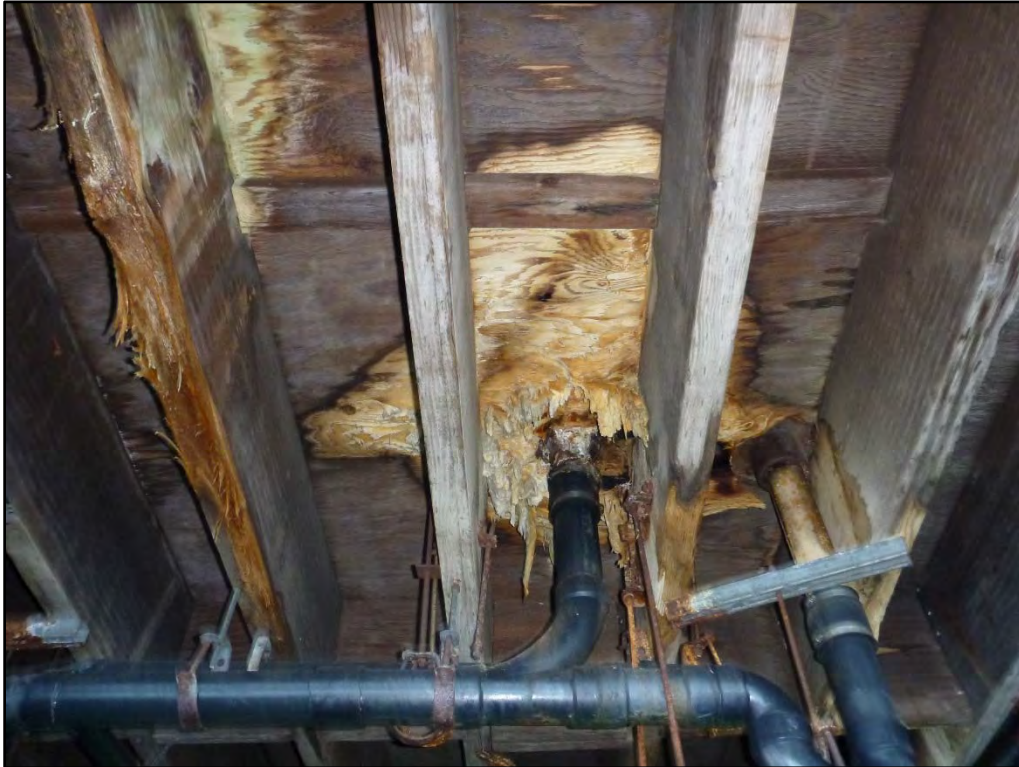
The plywood is in fair condition with the exception of some areas affected by dry rot that are in poor condition. Areas of soft rot was noted and primarily limited to the center portion of the structure where utility penetrations occur. An example of plywood in poor condition is seen in the vicinity of Grid 10:F in Photo 27.

Photo 27. The plywood surrounding the utility is severely affected by soft rot.

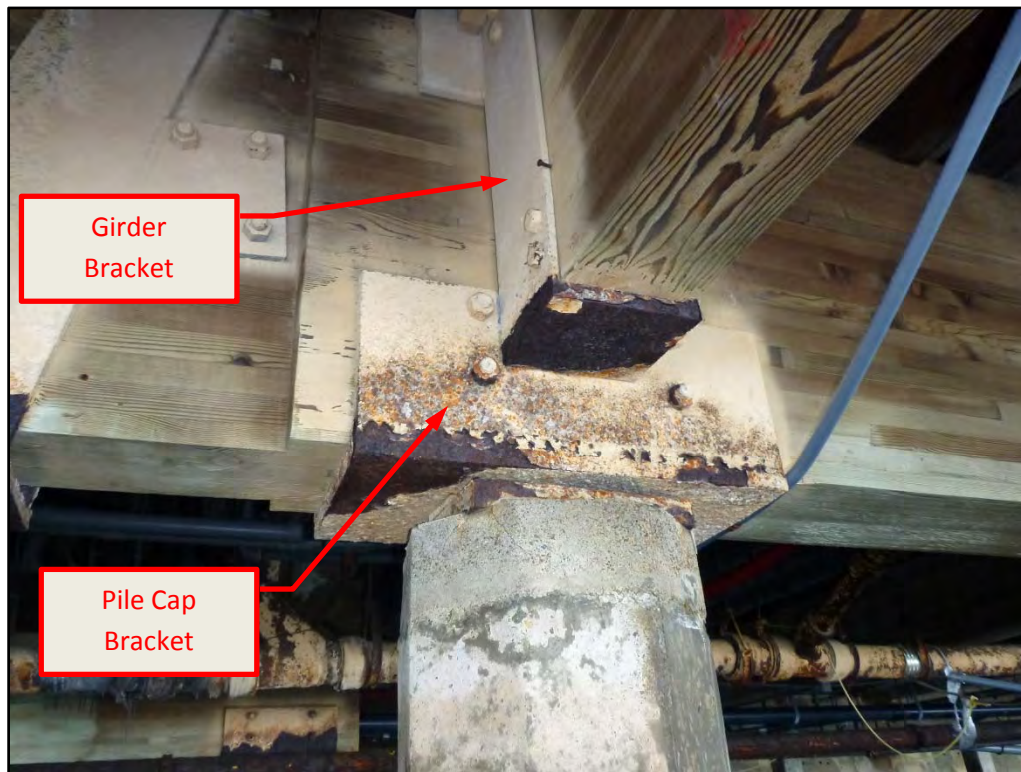
Photo 28. Typical condition where minor corrosion is noted on most surface areas of the steel connectors and moderate corrosion on the bottom plates (Pile 7:G).

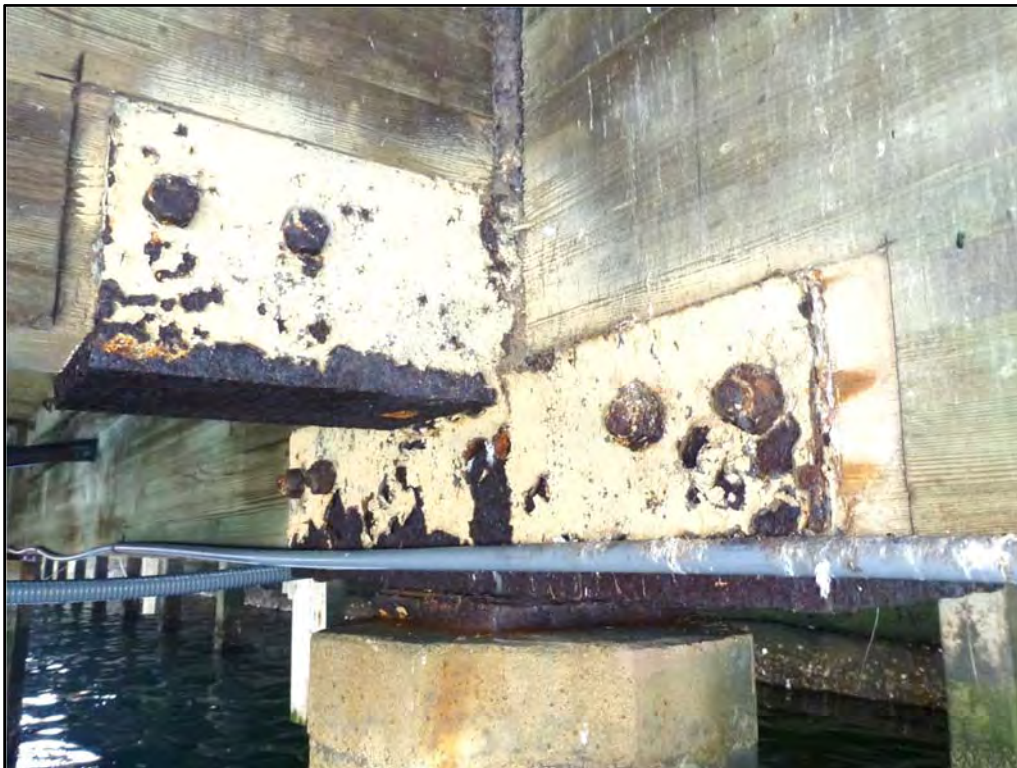
surfaces are in “fair” condition as defined in Appendix B, the connectors are assigned an overall corrosion loss rating of “moderate” because of the advanced corrosion noted on the pile cap connection hardware and the bottom plate of the connection bracket. An example of moderate corrosion is seen in Photo 31.

Photo 31. Pile 3:J. Moderate corrosion noted on the pile cap connection hardware and the bottom plates of the pile cap bracket and girder bracket.

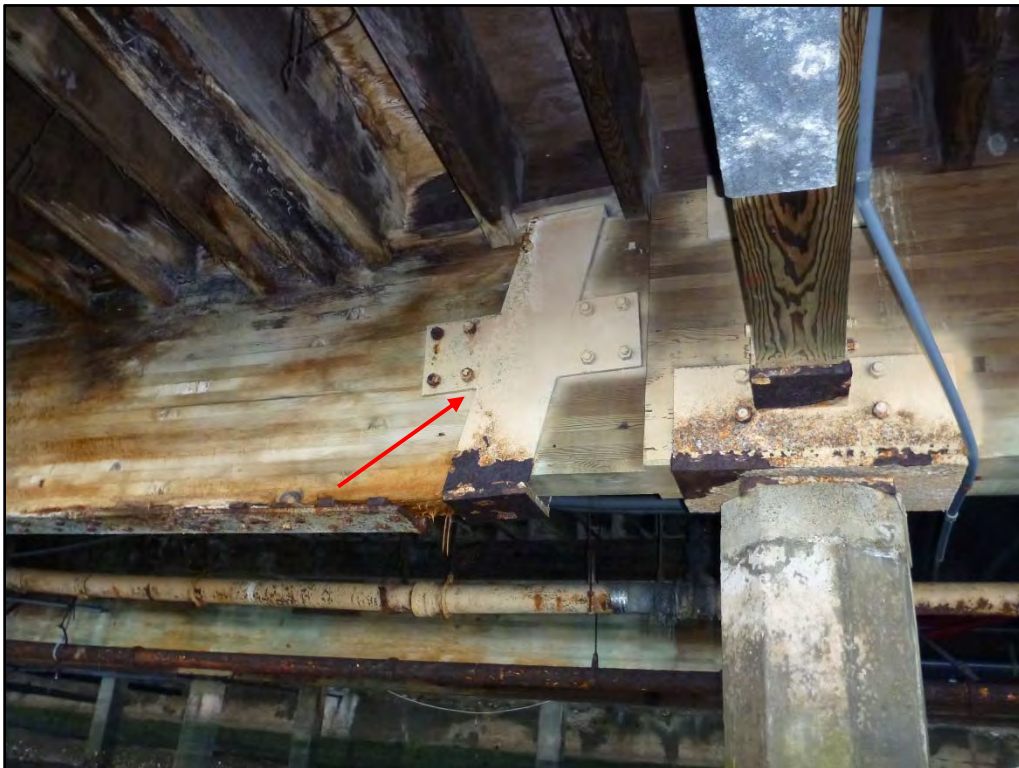
Cantilever Girder Hinge Connectors. The hinge connectors are in fair condition with moderate corrosion limited to the bottom of the hardware, see Photo 33.

Photo 33. The arrow points to a typical cantilever hinge connector located to the north of Grid 7:G.

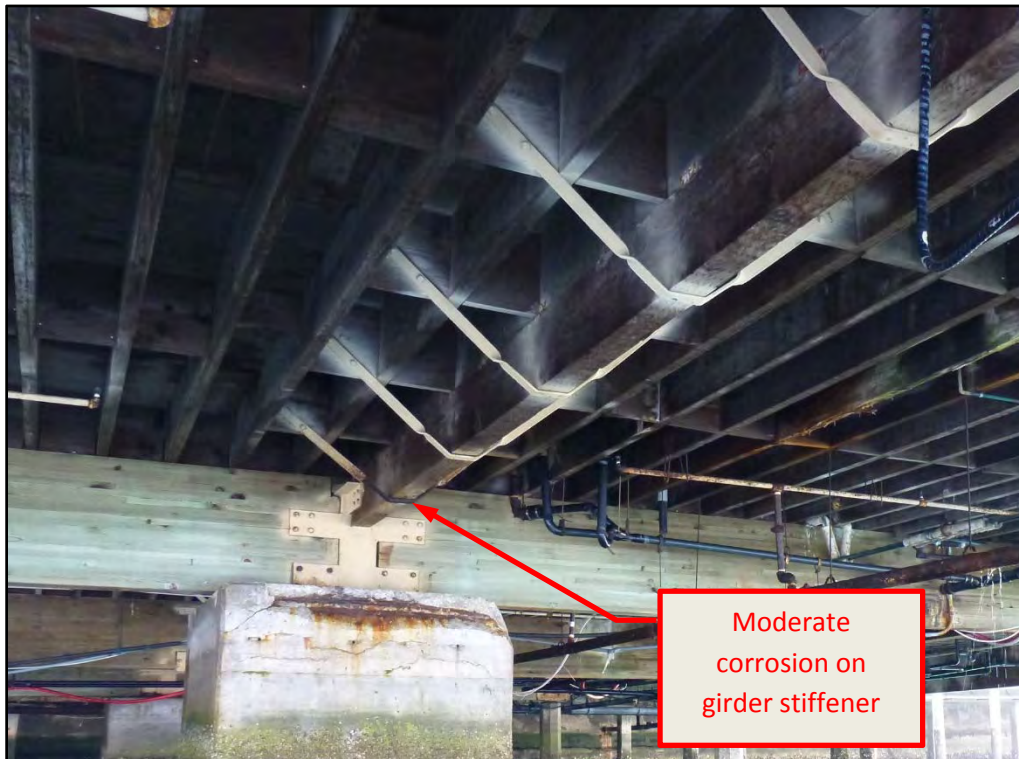
Girder Knee Braces. The girders have knee braces to stiffen the deep cross-section (five in each bay) on Gridlines 5 and 13. The braces are in satisfactory condition with the exception of the easternmost bracket in each bay which exhibits moderate corrosion, see Photo 34.

Photo 34. Girder stiffeners along the girder spanning from A to C on Gridline 5.
