WATERFRONT FACILITY INSPECTION AND ASSESSMENT FUTURE PORTSIDE PIER RESTAURANT

March 18, 2016

Attention: Mr. Greg Mueller, Principal
Subject: Waterfront Facility Inspection and Assessment (WFI)
Future Portside Pier Restaurant San Diego, CA

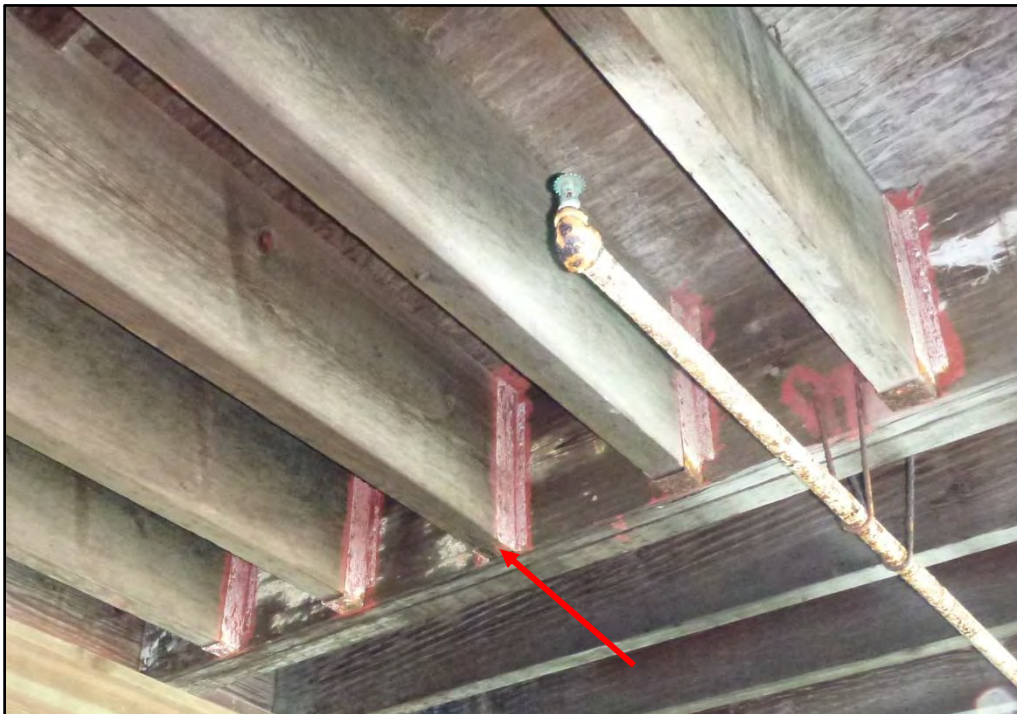
Joist Hangers. The joist hangers are in poor condition – primarily because the hangers were fabricated from thin sheet metal. Severe corrosion was noted on the bottom sections of joist hangers and in some cases the bottom section has completely corroded away, see Photo 35.

Photo 35. Corroded Joist hangers in the vicinity of Grid 2:B. the red arrow points to a hanger which has lost 100% of the bottom section.

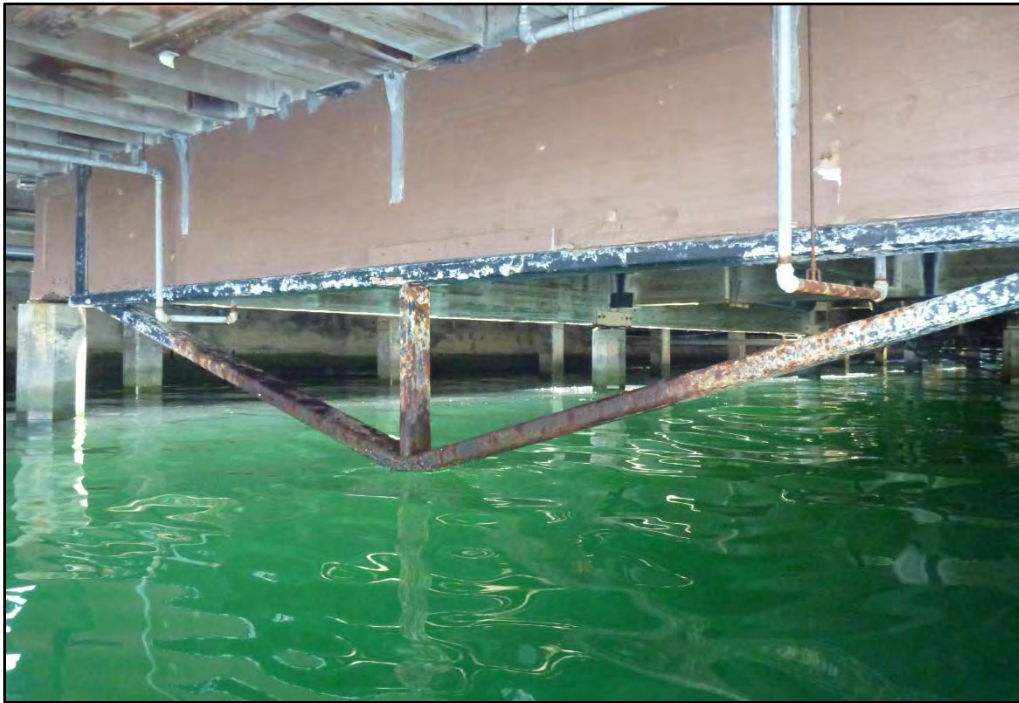
Built-up Pile Cap. An inverted steel truss comprised of Hollow Structural Sections (HSS) has been added underneath the pile cap spanning from G to J on Gridline 17. This was added to provide additional support for the cantilevered deck addition associated with the Star of the Sea room. The truss is in fair condition with moderate corrosion, see Photo 36.

Photo 36. Inverted truss pile cap stiffener at Grid H:17.

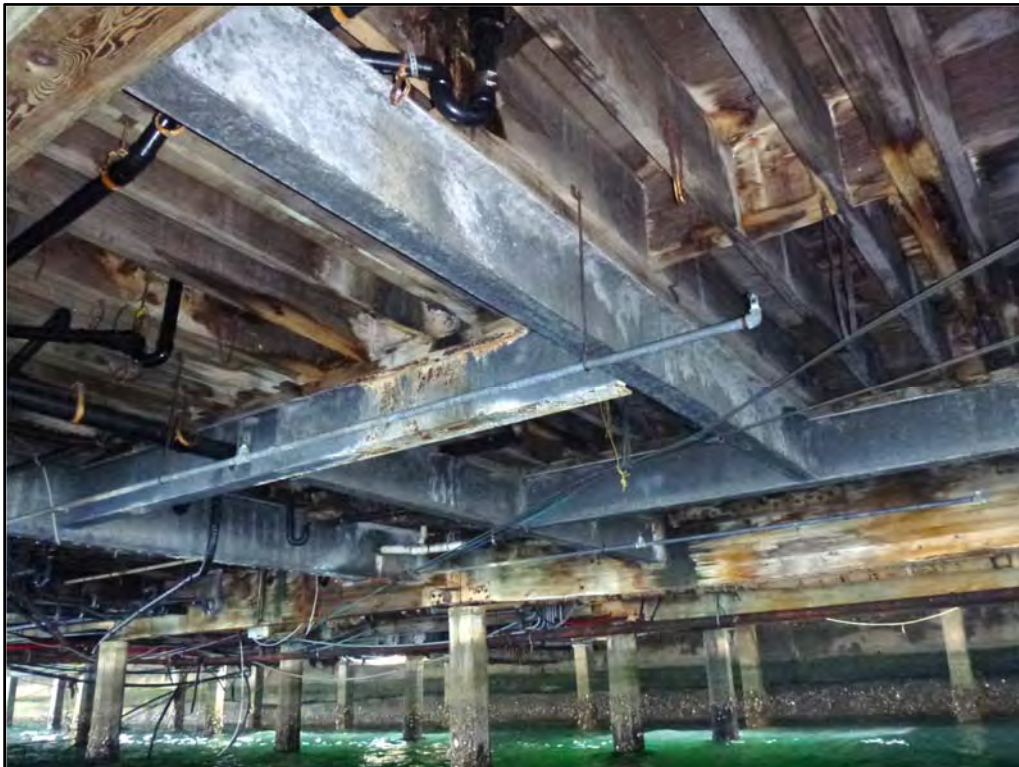
Steel Retrofit Section. Galvanized steel cold-formed Z-sections have been added in the bay bounded by Grids E, G, 7, and 9. The timber framing in this area shows signs of more advanced soft rot, and it is speculated that the cold-formed framing was added to provide supplemental load capacity. The retrofit, seen in Photo 37, is in fair condition with localized areas of minor corrosion.

Photo 37. The photo shows the retrofit with cold-formed steel Z-sections in the area bounded by Grids E, G, 7, and 9.

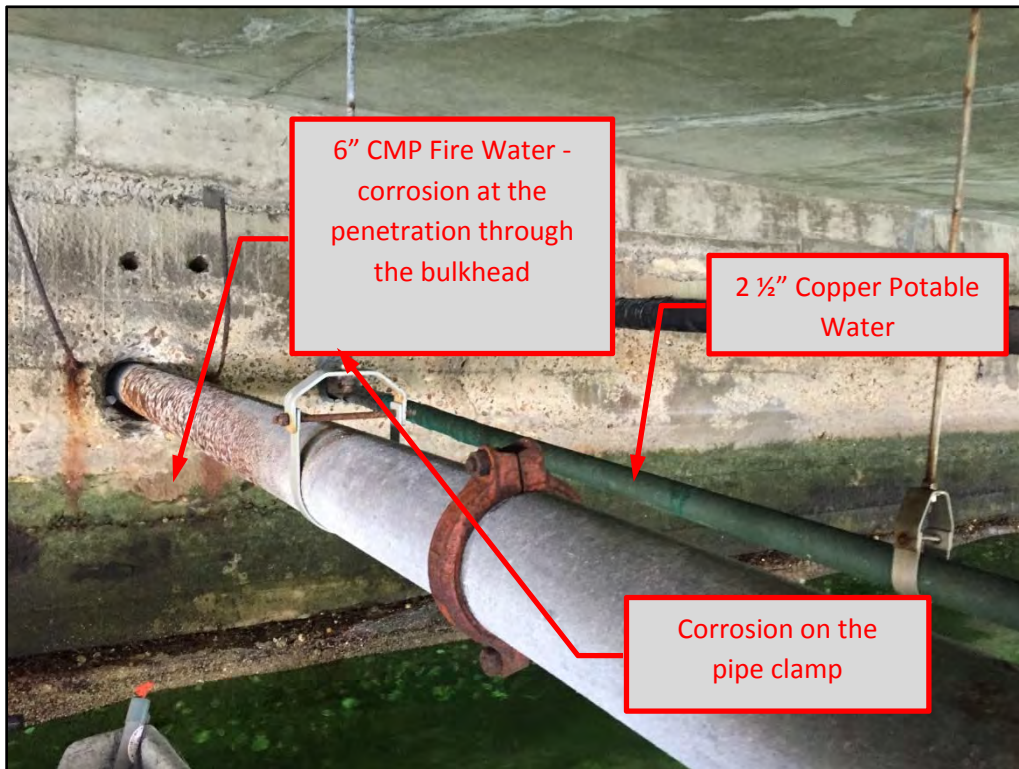
The pipe hangers under the Embarcadero Wharf are in fair condition with some corrosion evident in some of the hardware. The pipe fittings show evidence of heavy corrosion and are in poor condition – see Photo 38 through Photo 40.

Photo 38. Existing 6-in. CMP Fire Water line showing corrosion on the landside connection of the pipe. The 2 ½-in. potable water line is seen behind the 6-in. pipe.

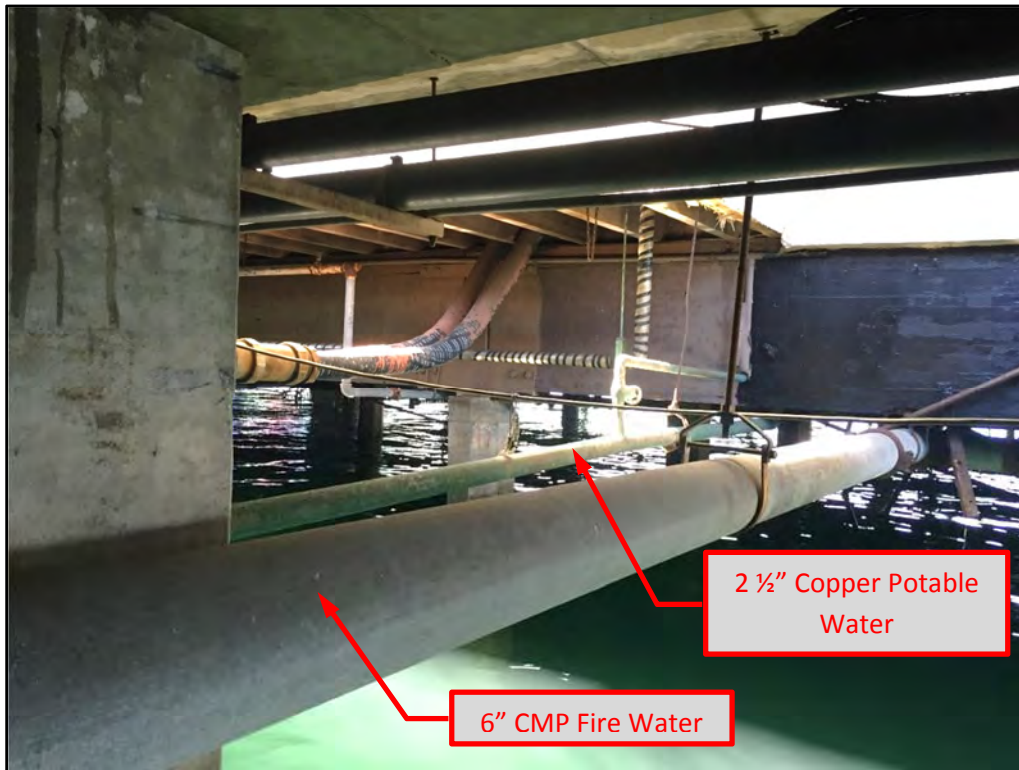
Photo 39. The 6 in fire water line and 2 ½-in. potable water line is seen extending beyond the Embarcadero Wharf towards the underside of the platform.

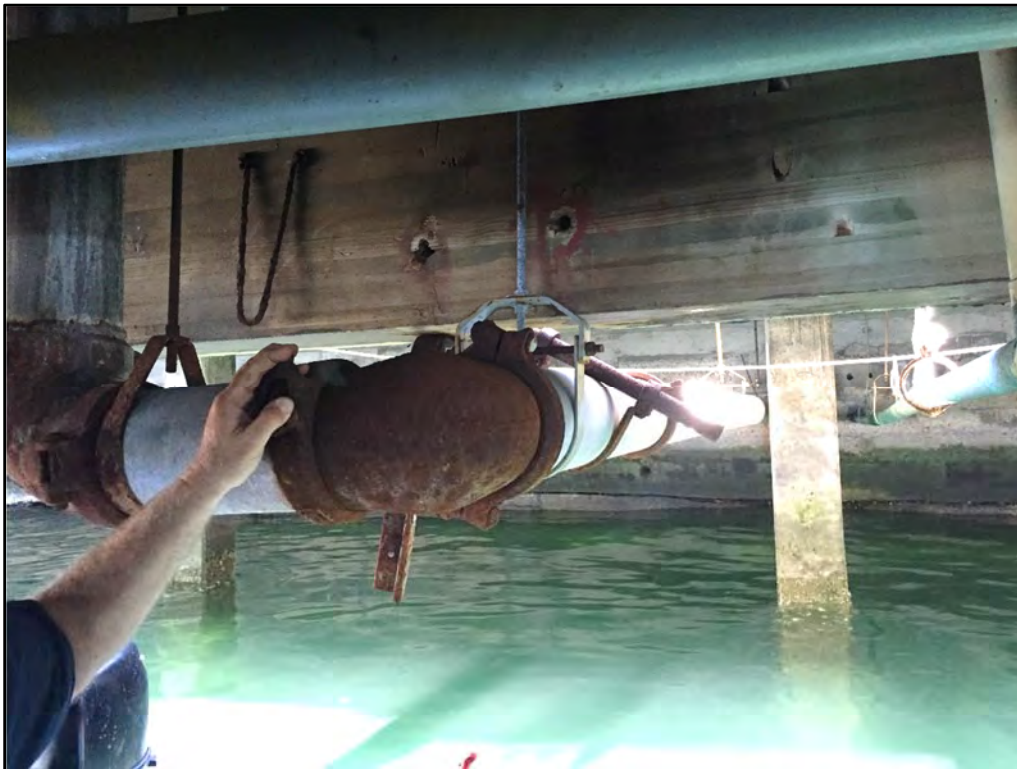
Photo 40. The photo shows corrosion of the elbow fitting on the 6-in. fire water line. The photo was taken looking from beneath the platform back at the Embarcadero bulkhead.

Corrosion on the pipe hangers can be seen in Photo 40 and Photo 41. In addition, Photo 41 shows evidence of bending at the lateral fitting. These signs of both bending and corrosion warrants a condition rating of poor for the hangers and fittings.

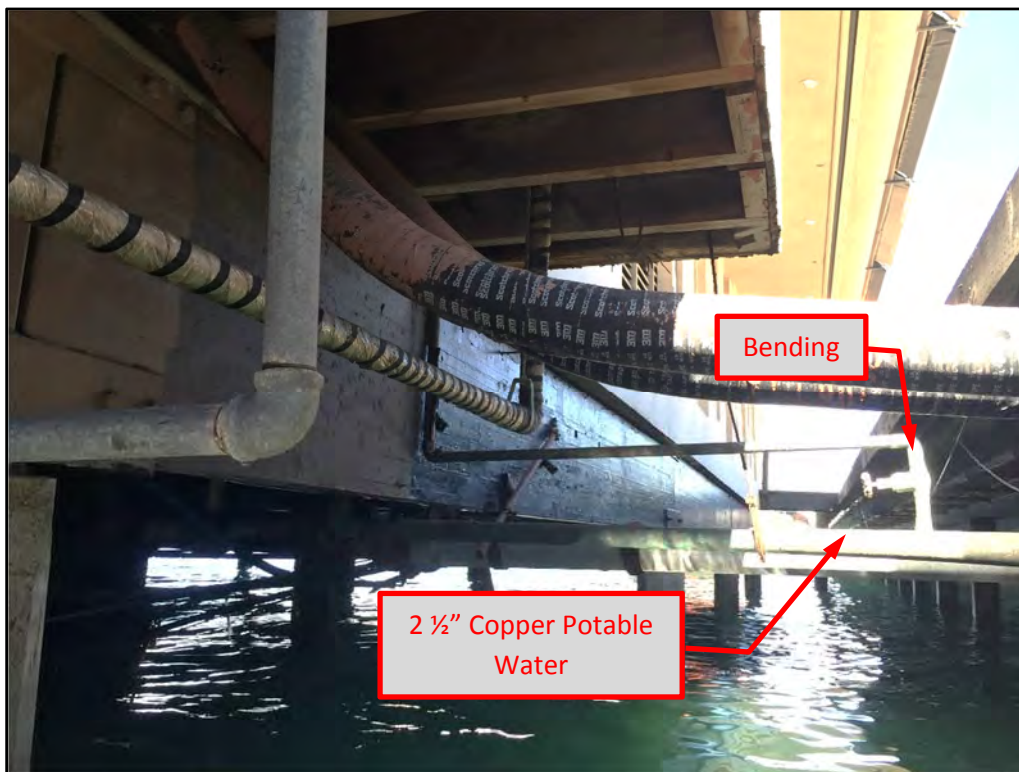
Photo 41. Bending shown in the lateral coming off the 2 ½-in. Potable Water line.

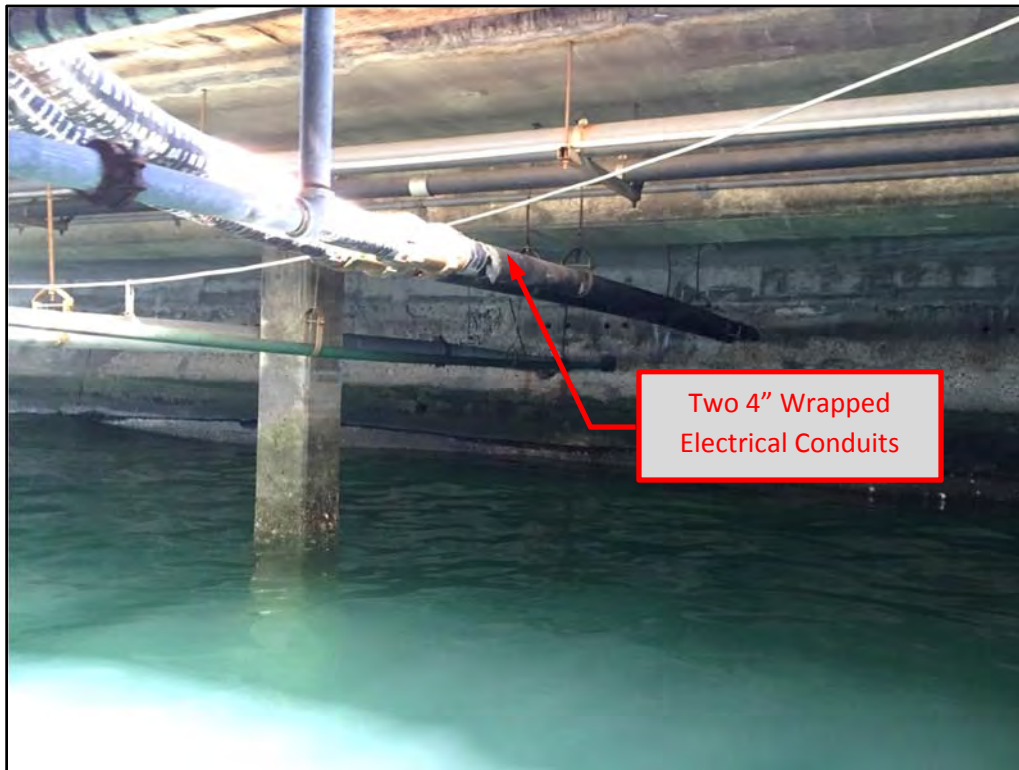
Photo 42 and Photo 43 show that the pipe hangers and fittings are in fair condition with corrosion evident in only some of the hardware elements. It is important to note that the spacing and number of the pipe hangers need to be validated.

Photo 42. View of the electrical conduits.

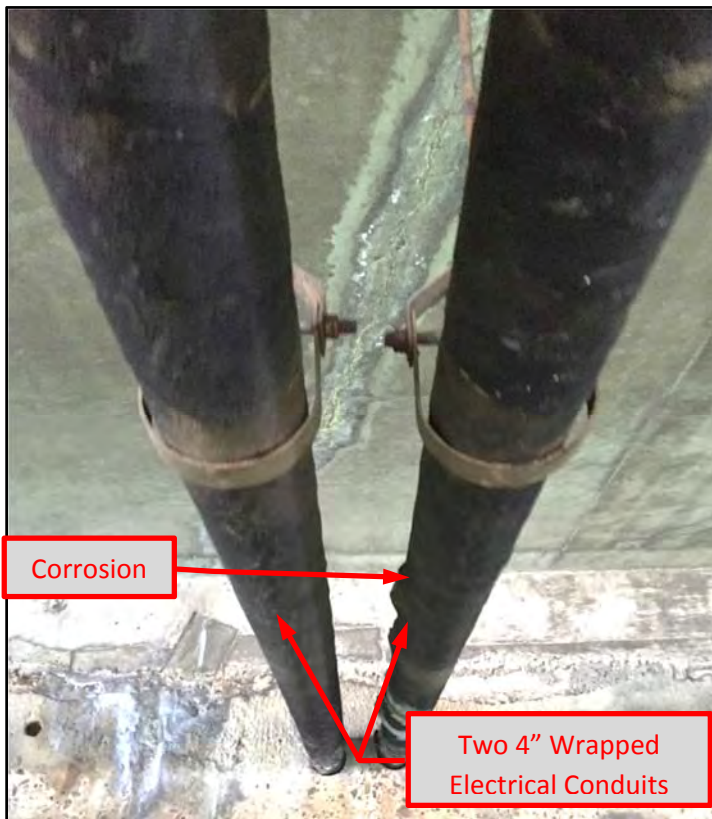
Photo 43. Underside view of the electrical conduits showing corrosion damage.

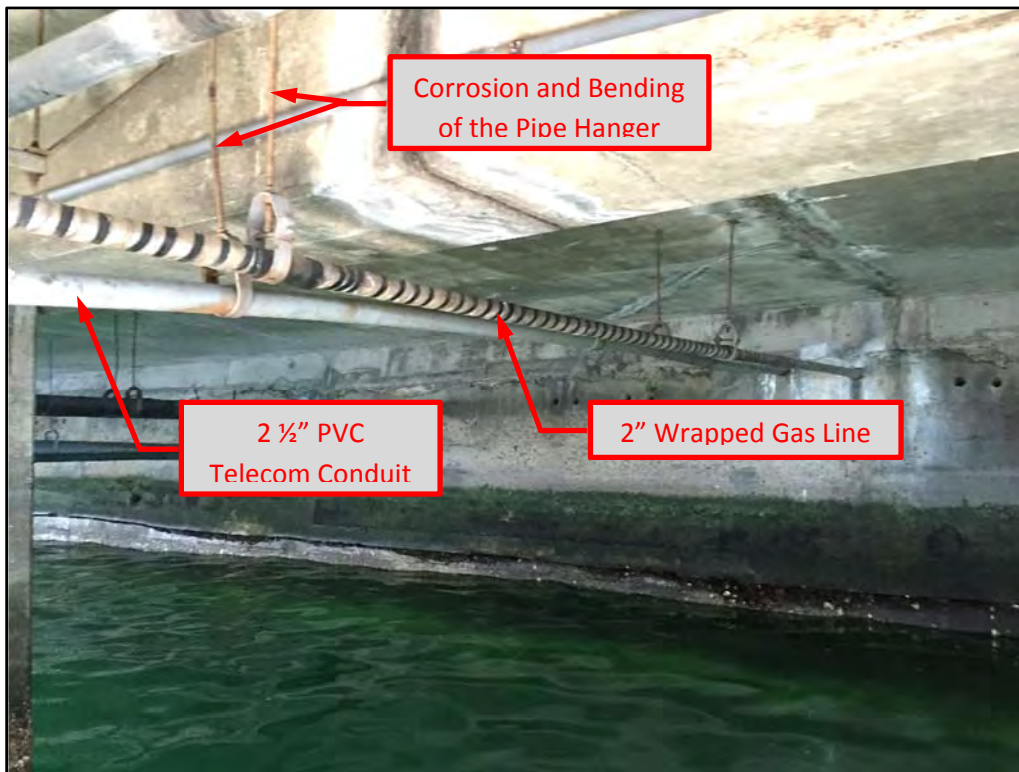
Inspection of the pipe hangers show evidence of both bending and corrosion on the hangers which can be seen in Photo 45. Evidence of the corrosion and bending of the hangers justify a condition rating of poor.

Photo 45. View of the Telecom and Gas line showing bending and corrosion on the hanger.

Inspection of the pipe hangers show evidence of both bending and corrosion on the hangers which can be seen in Photo 45. Evidence of the corrosion and bending of the hangers justify a poor condition rating. However, the saddles had little deterioration and are in fair condition.

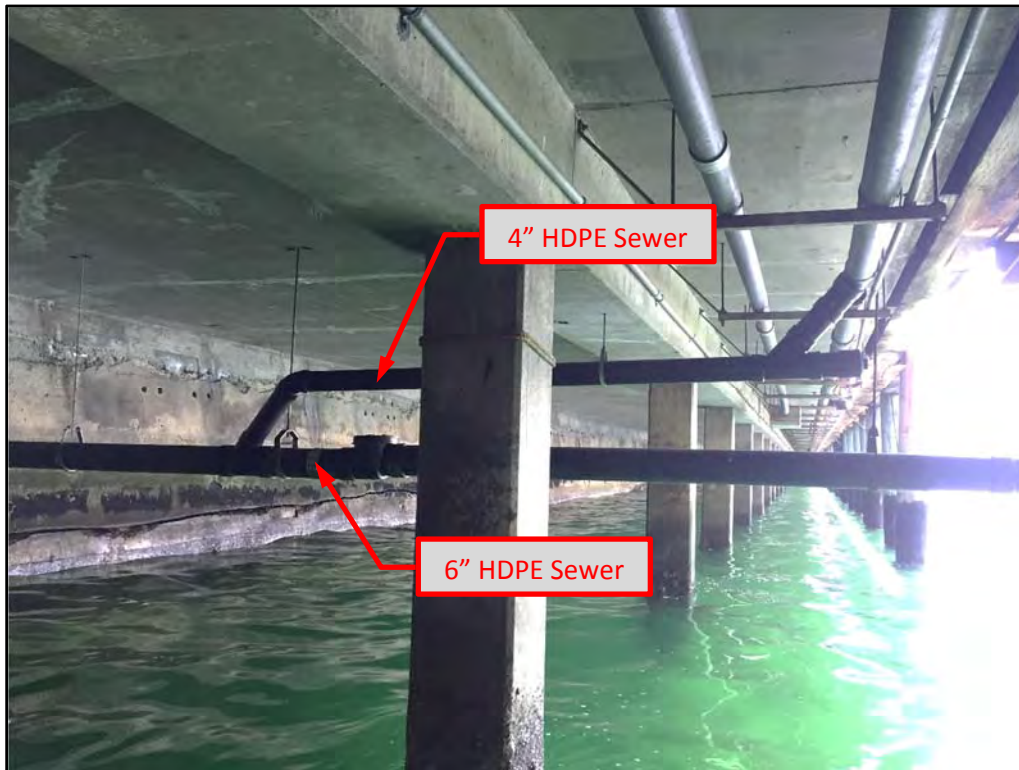
Photo 49 – Photo 51 also show that the pipe hangers and fittings are in satisfactory condition with little corrosion evident on the sewer system components.

Photo 49. South View of the Sewer System.

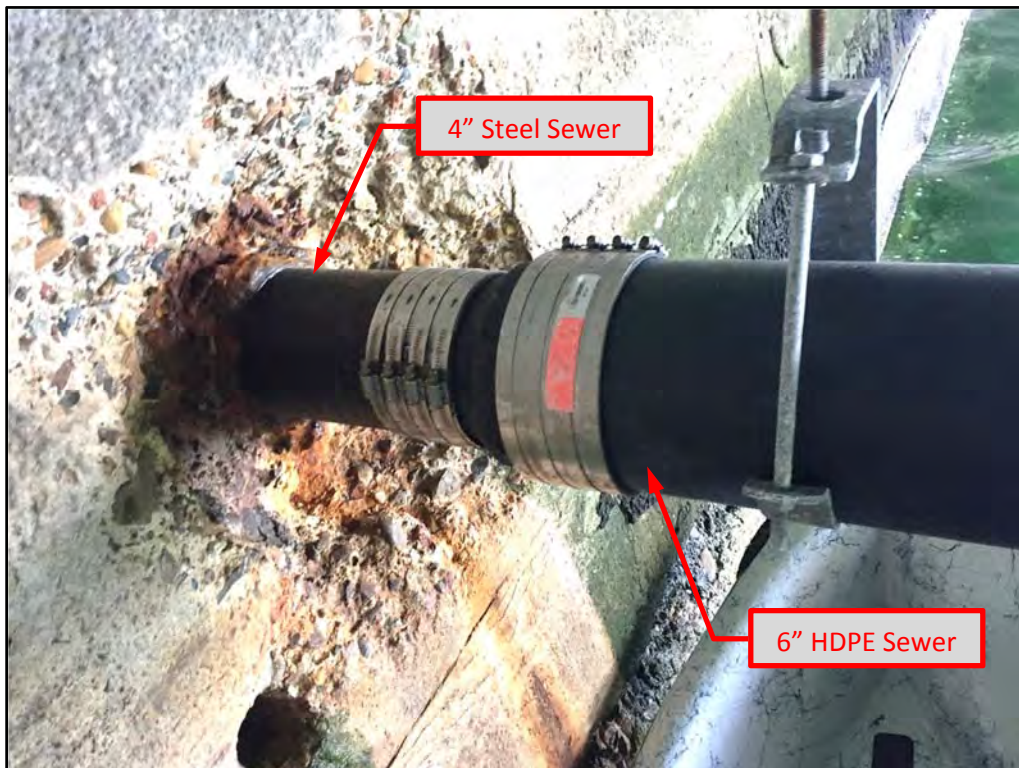
An existing Sewer System was found approximately 3'-10" below the bottom of the structure and 6-ft south of Embarcadero Wharf Pile No. 60. The system is composed of a 6-in. High Density Polyethylene Pipe (HDPE), a 4-in. HDPE lateral, 4-in. steel pipe (landside), galvanized hangers and HDPE fittings. Upon inspection, both the 4-in. and the 6-in. HDPE sewer line generally appeared to be in satisfactory condition and had little to no deterioration (see Photo 49 - Photo 51). However, corrosion was noted at the landside connection of the sewer system.

Photo 50. View of the Reducer at the Landside Connection.

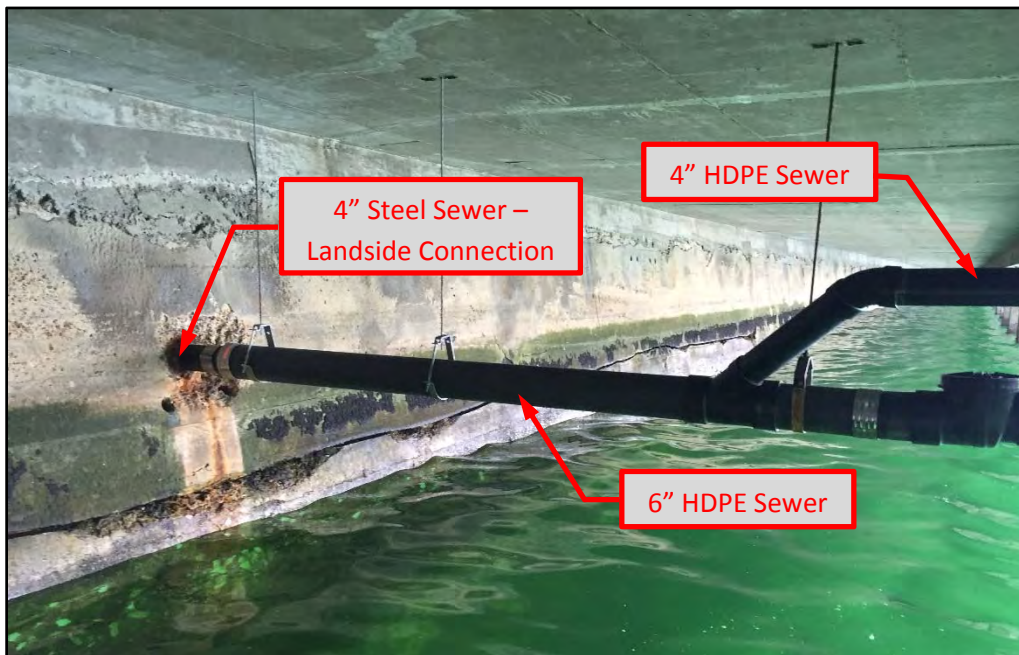
Photo 51. View of the Pipe Hangers and Sewer System.
