Site Damage Caused by Storm

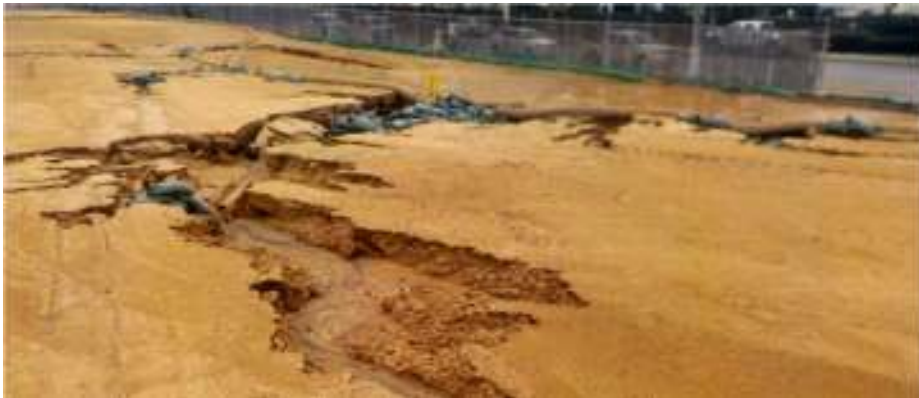
Site Damage Caused by Storm

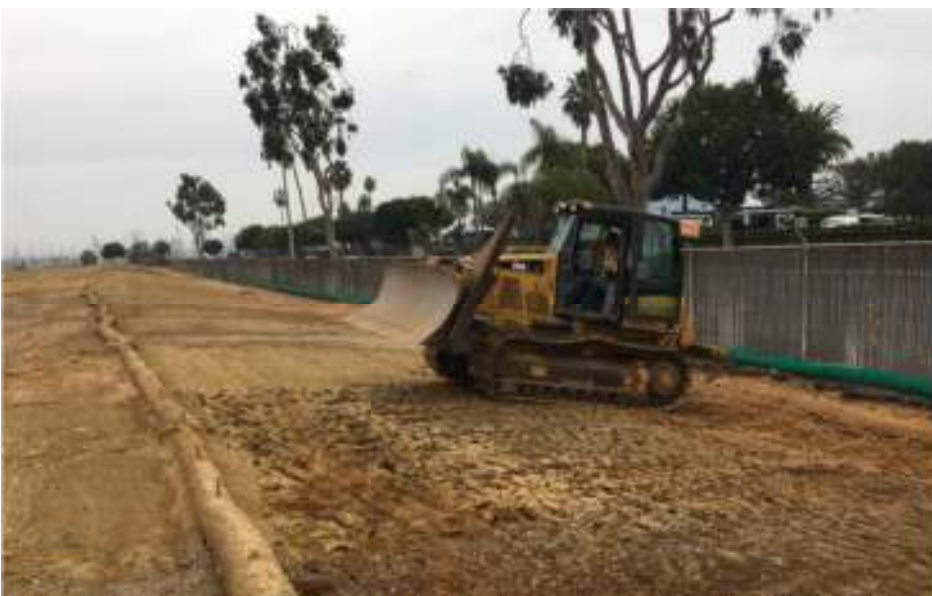
Best Management Practice (BMP) – Slope Tracking

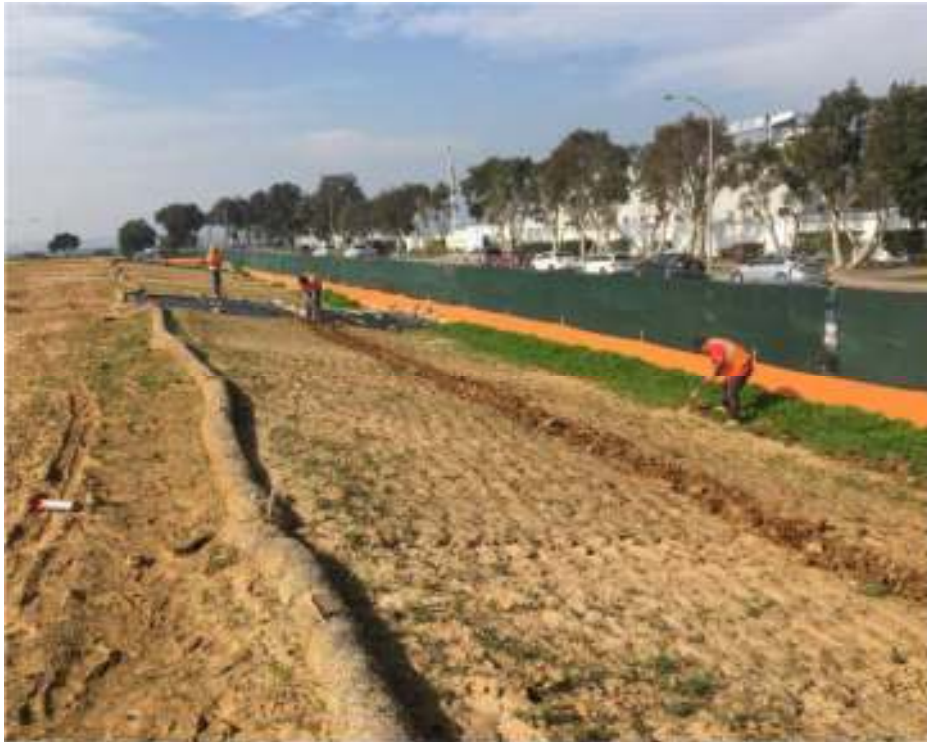
BMP Installation – Fiber Rolls

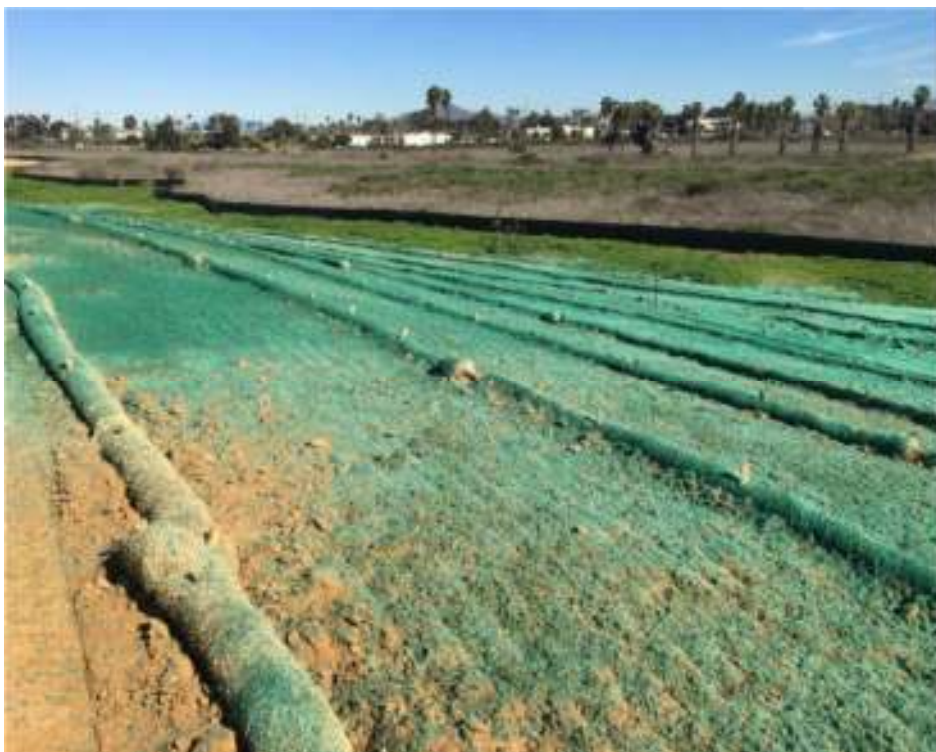
**Installed BMP – Fiber Rolls and Bonded Fiber Matrix with
Hydroseed**

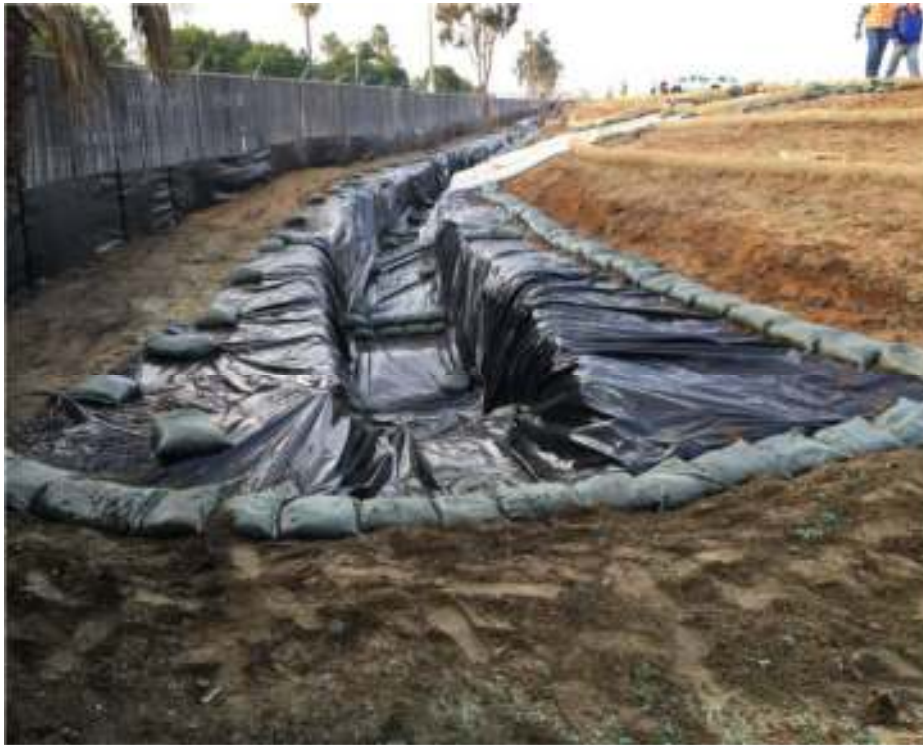
Installed BMP Before Rain Event – Sediment Trap

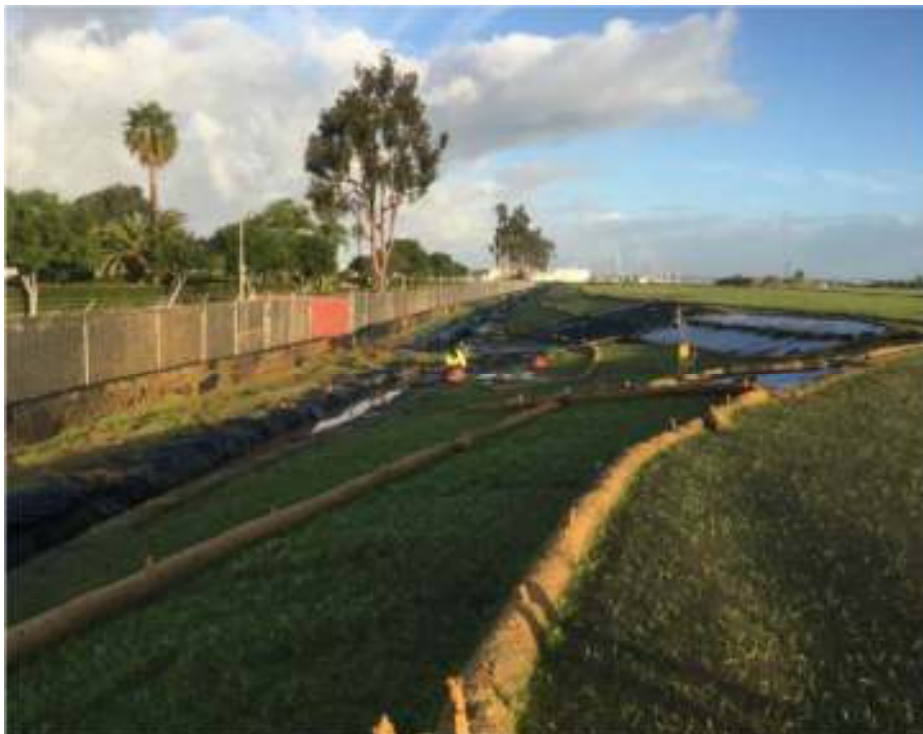
Installed BMP After Rain Event – Sediment Traps, Pumps, Fiber Rolls and Bonded Fiber Matrix with Hydroseed

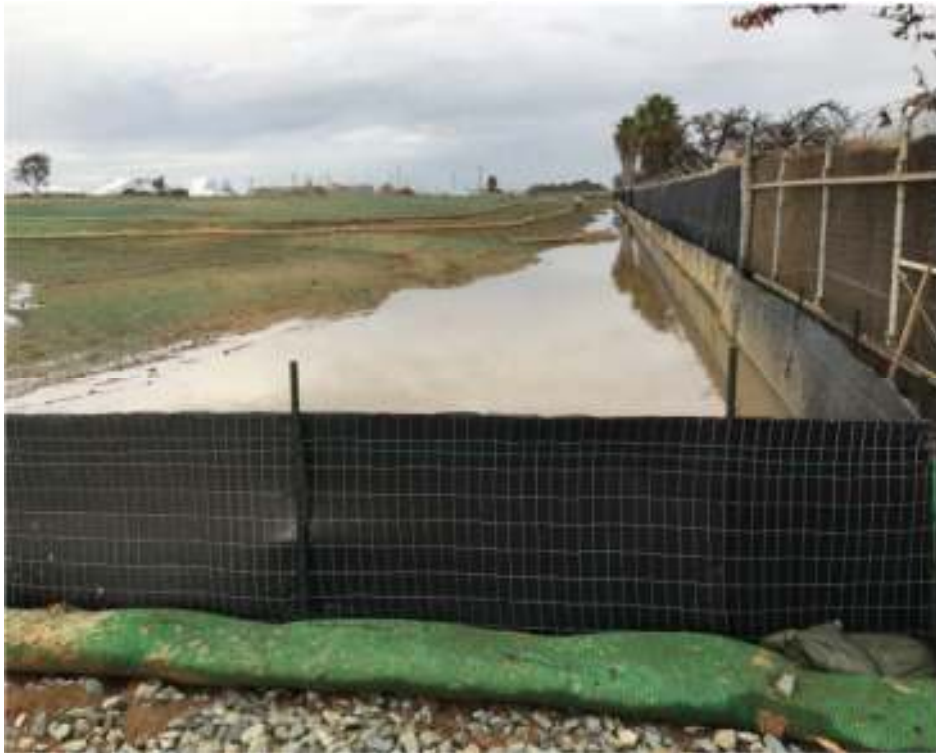
Installed BMP After Rain Event – Sediment Traps and Wire Backed Silt Fence

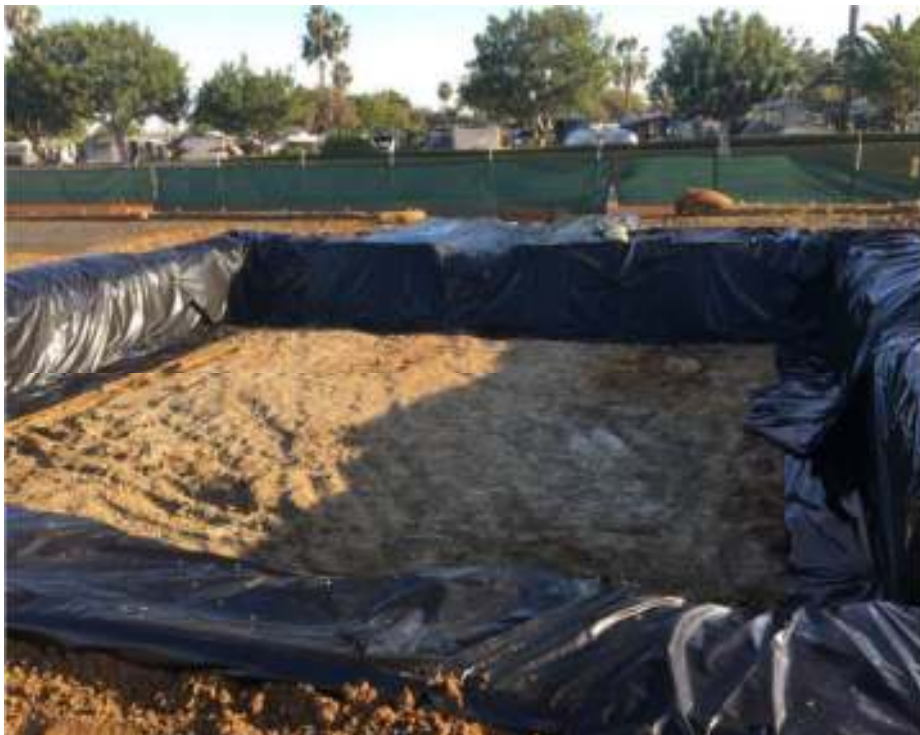
Installed BMP Before Rain Event – Sediment Trap

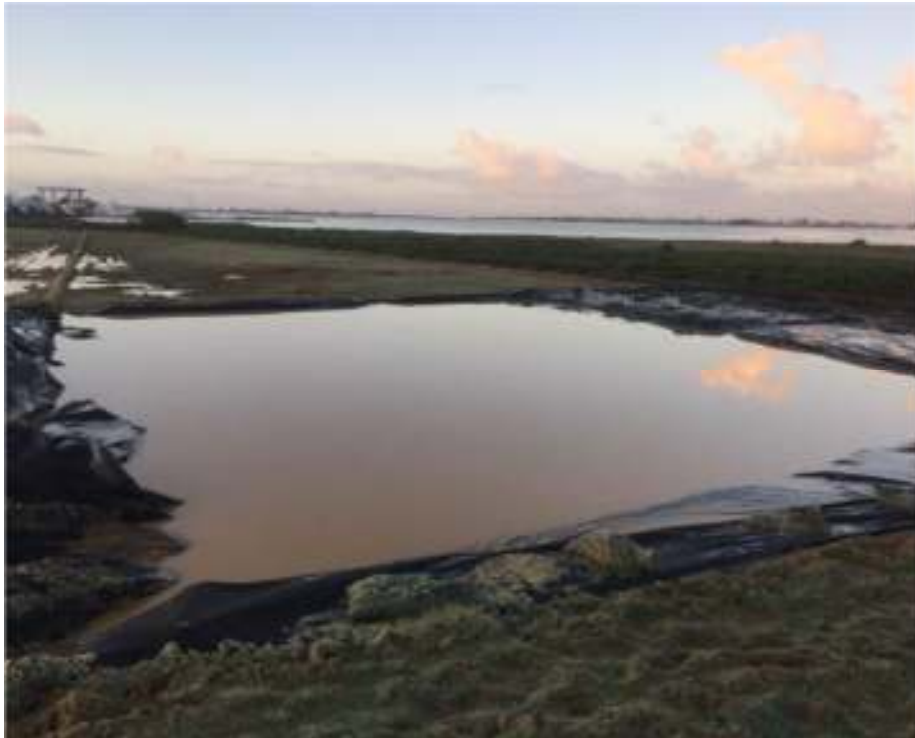
Installed BMP After Rain Event – Sediment Trap

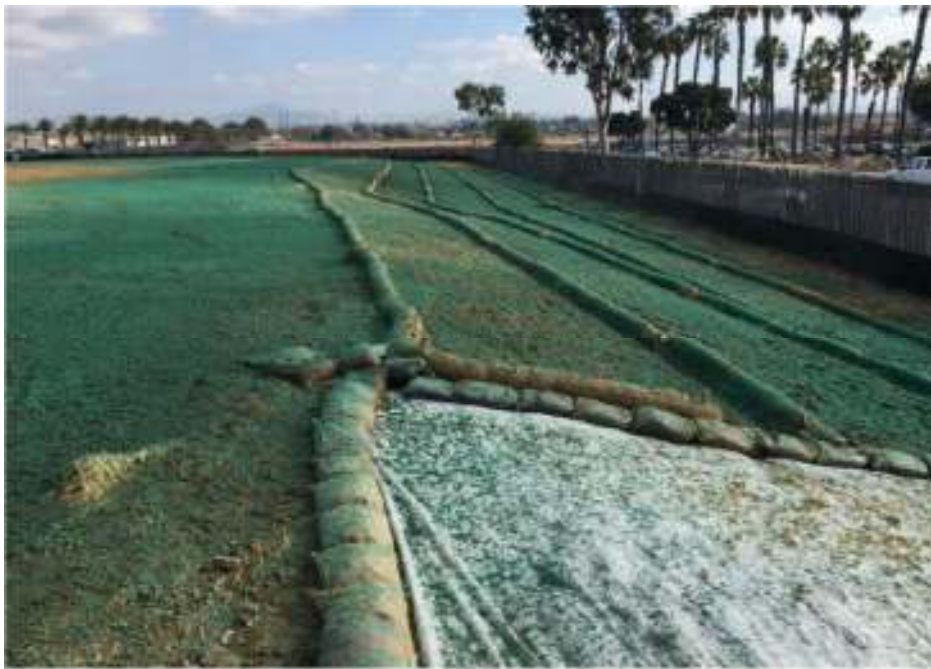
BMP – Hydroseed

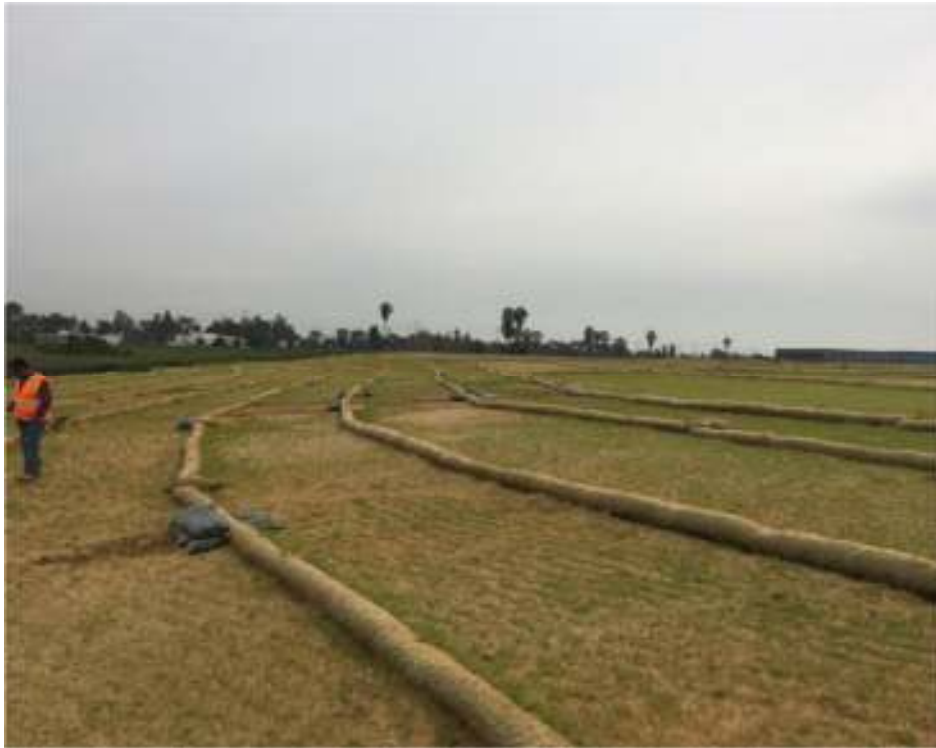
BMP – Hydroseeded Vegetation sprouting

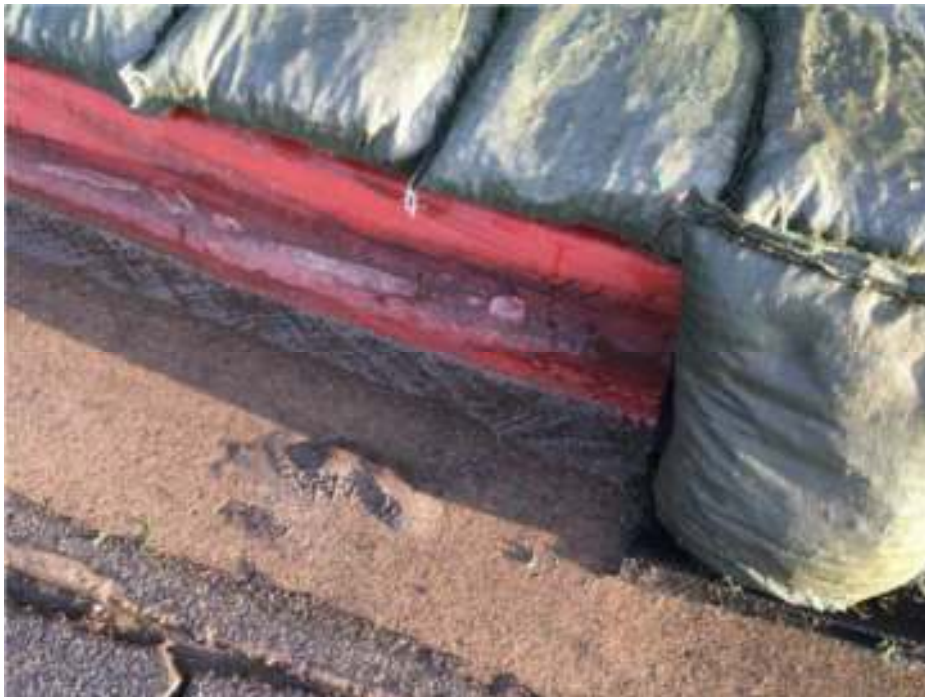
Stormwater Runoff into MSA-4
