Attachment B – Photographs

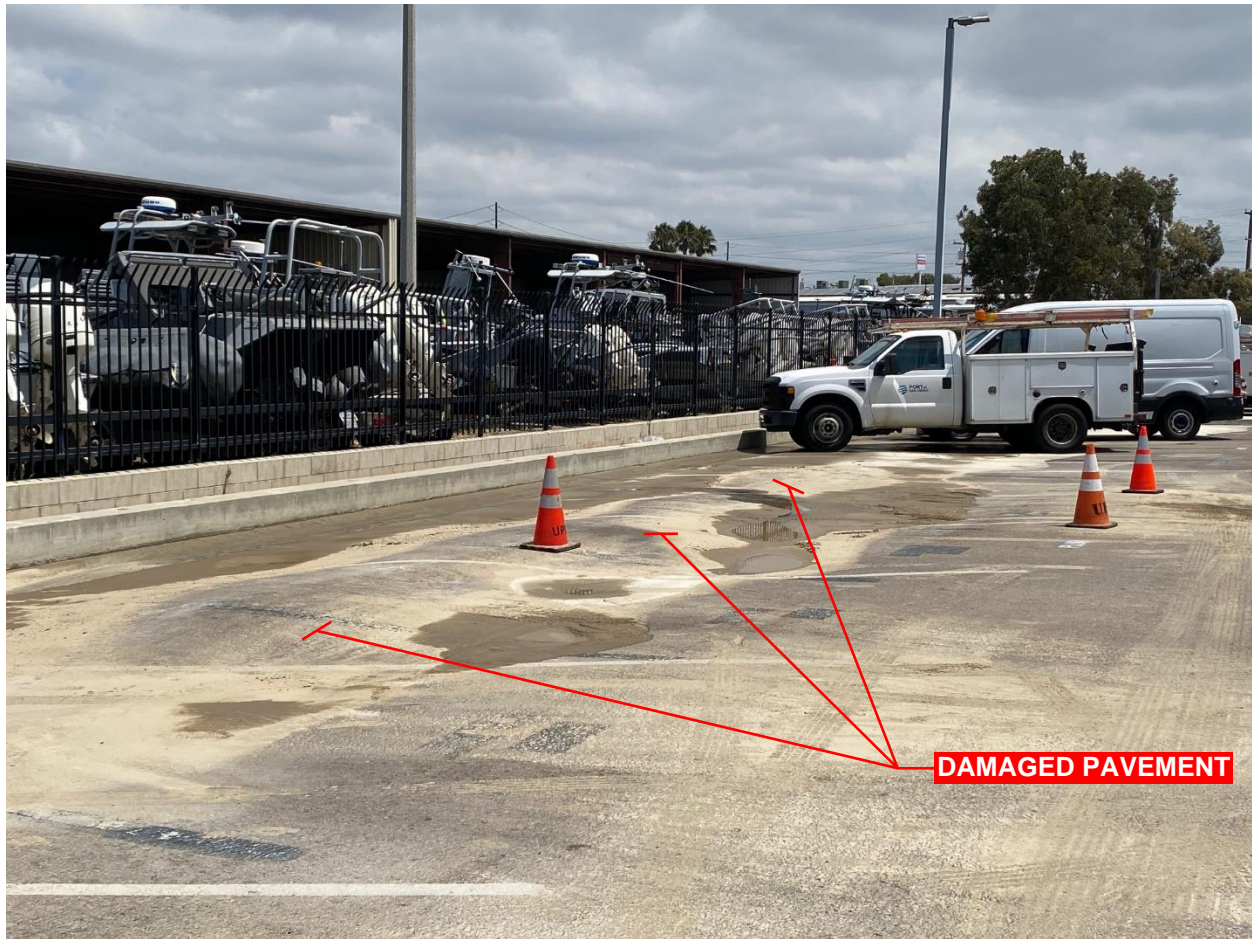
Note: It appears base has collapsed and void under pavement goes to foundation wall (6-12") and then slopes to bottom of hole.
